Property Inspection Report

325 Squaw Valley Rd, Olympic Valley, CA 96146

Date of Inspection: 4/4/2019 Time: 9:00 AM

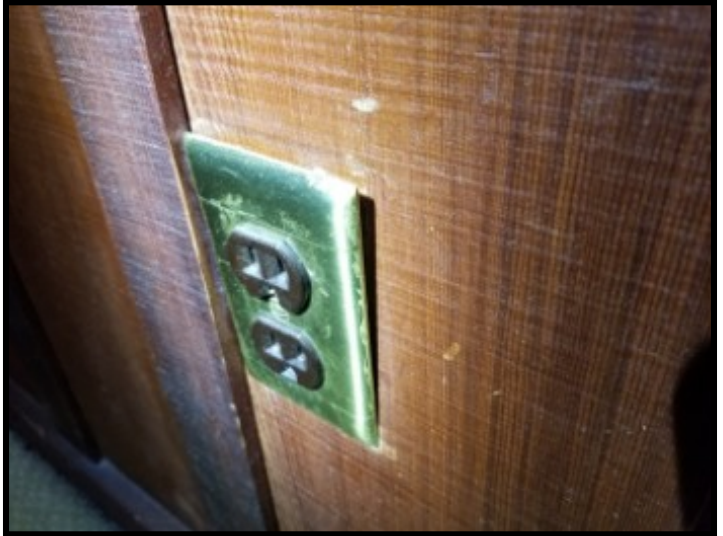
1.2. Loose outlet in master bedroom near door

Loose outlet in master bedroom near door

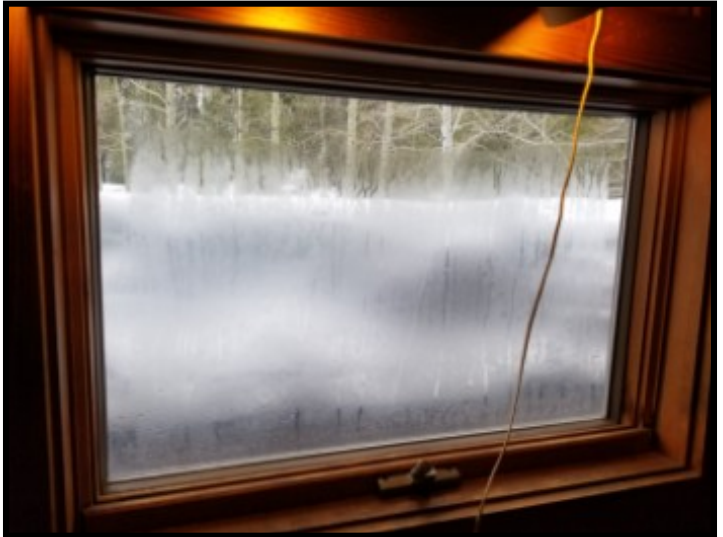
4.2. Cloudiness/condensation observed in double pane window in upstairs guest bedroom. This is an indication of a failed seal. A qualified contractor should review for replacement as needed.

Failed window seal in upstairs guest bedroom

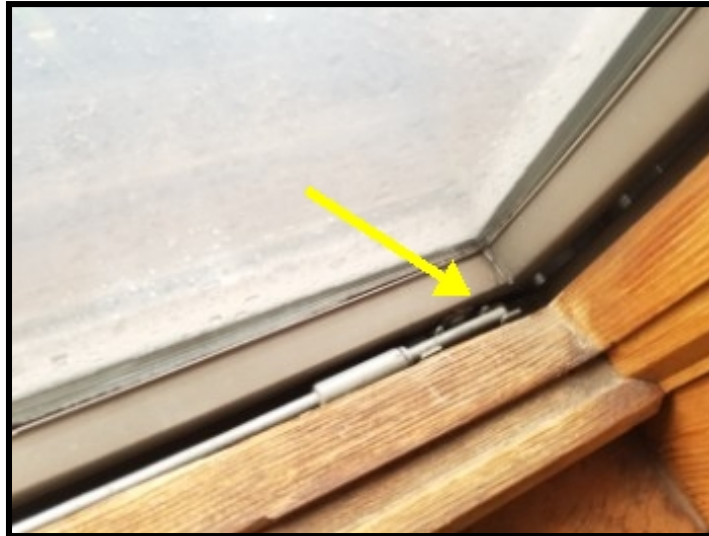
4.3. Left window in upstairs guest bedroom does not completely close. Needs adjustment

Window does not completely close in upstairs guest bedroom

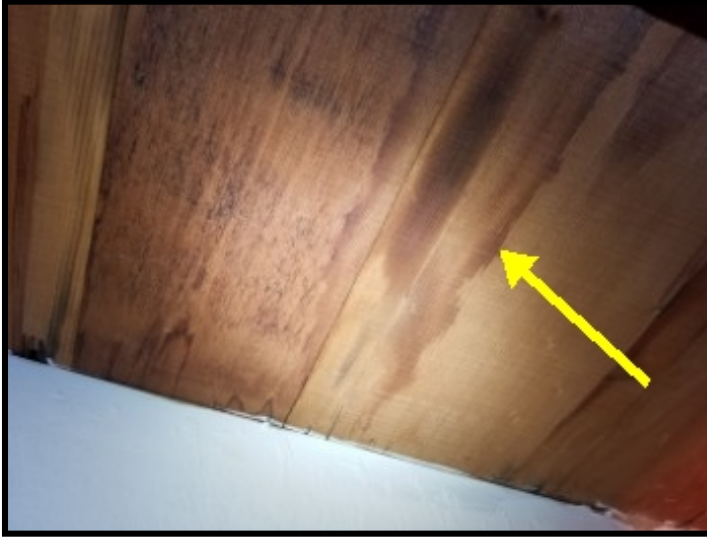
8.1. Water stains in master bedroom closet ceiling. Moisture meter readings indicate area was relatively dry at the time of inspection

Water stains in master bedroom closet ceiling

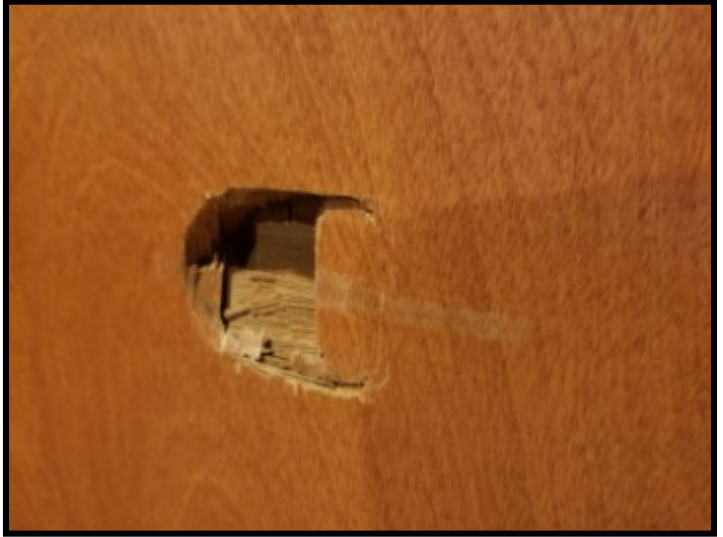
8.2. Hole in master bedroom closet door

Hole in master bedroom closet door

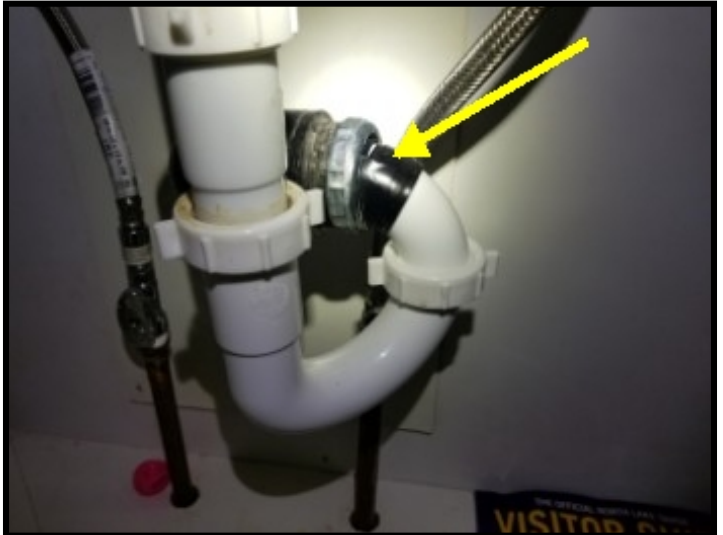
5.3. Loose and leaking drain line below entry level guest bathroom sink. Contact licensed plumbing contractor for repair

Leaky drain line below entry level guest bathroom sink

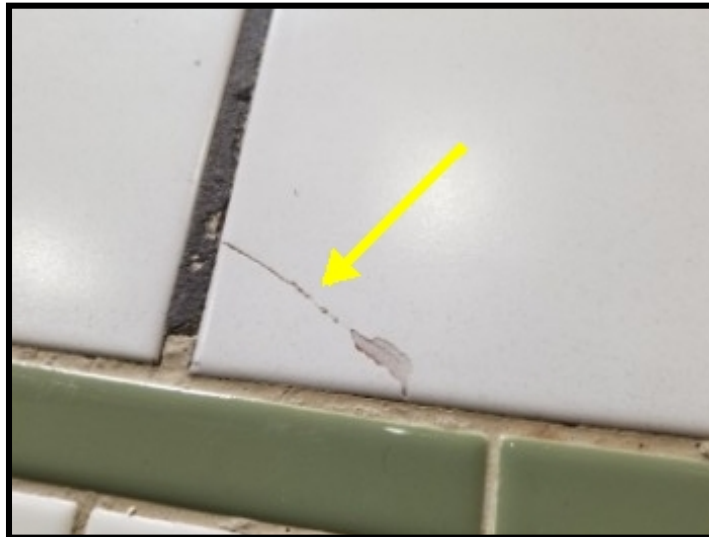
12.1. Cracked tiles noted in master bathroom

Cracked tiles noted in master bathroom

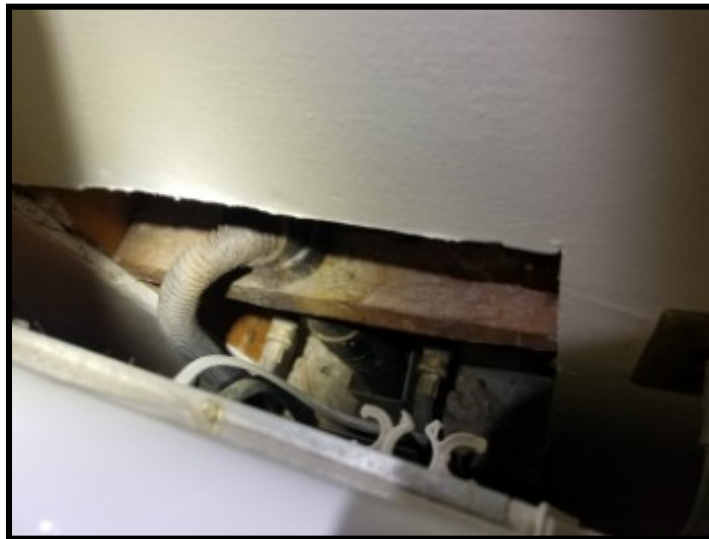
7.1. Opened drywall behind washer

Opened drywall behind washer

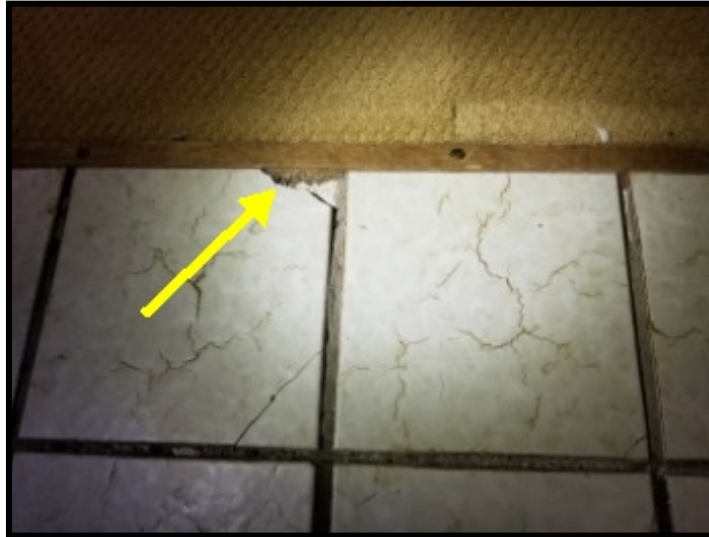
9.1. Cracked tile and damaged grout observed

Cracked tiles

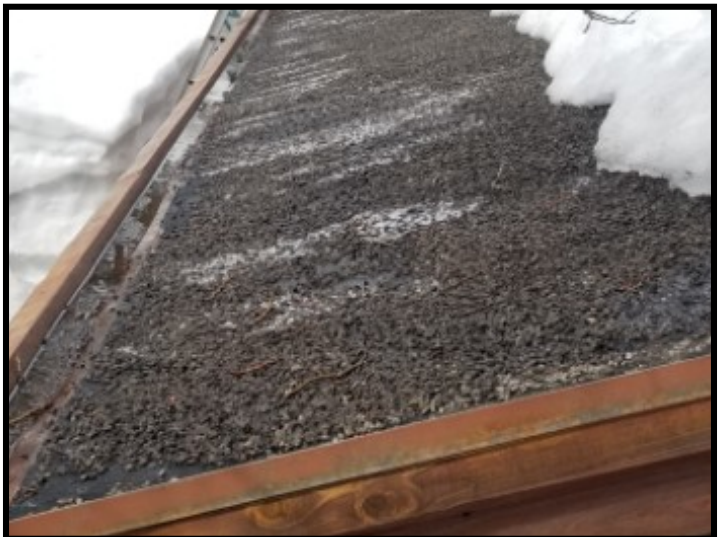
1.2. Gravel does not fully cover rolled roofing. Rolled roofing appears in marginal to poor condition. Recommend further evaluation by licensed roofing contractor

Visible rolled roofing in marginal to poor condition

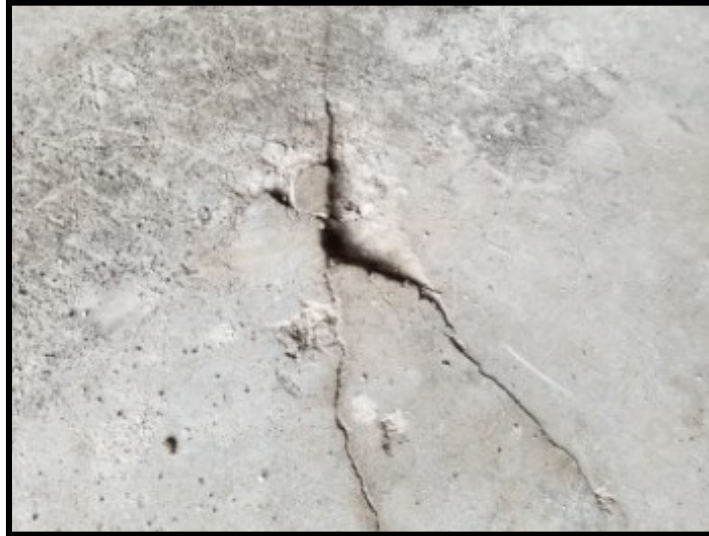
4.1. Cracked slab and missing concrete piece observed

Chunk of missing slab

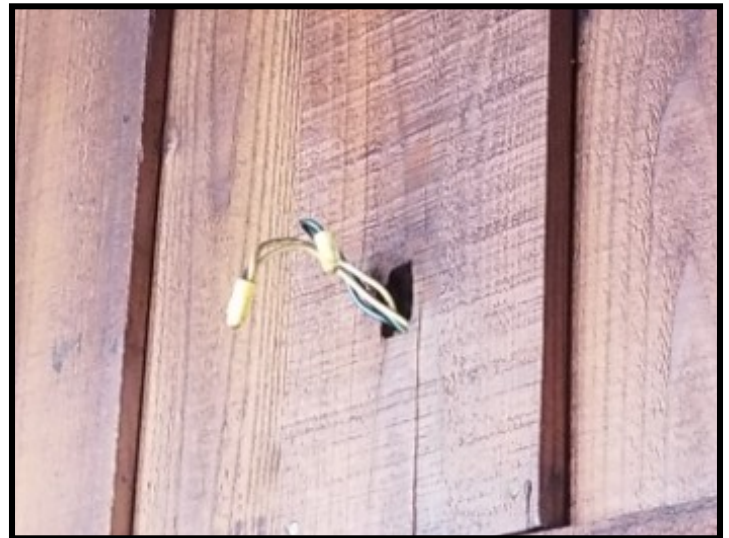
Exposed electrical wires above boiler enclosure

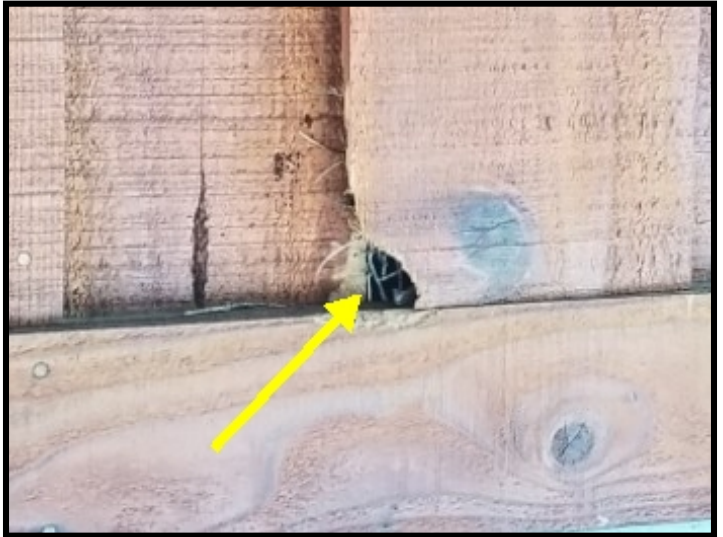
Bird damage on west side of pool building

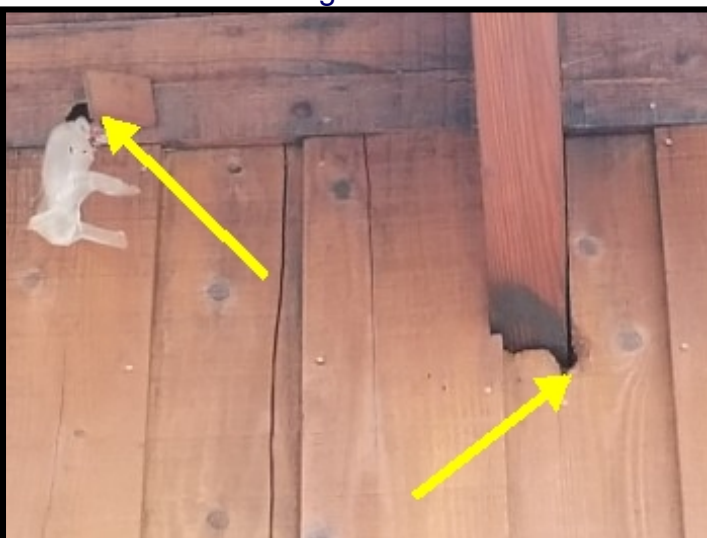
Bird damage on south side of pool

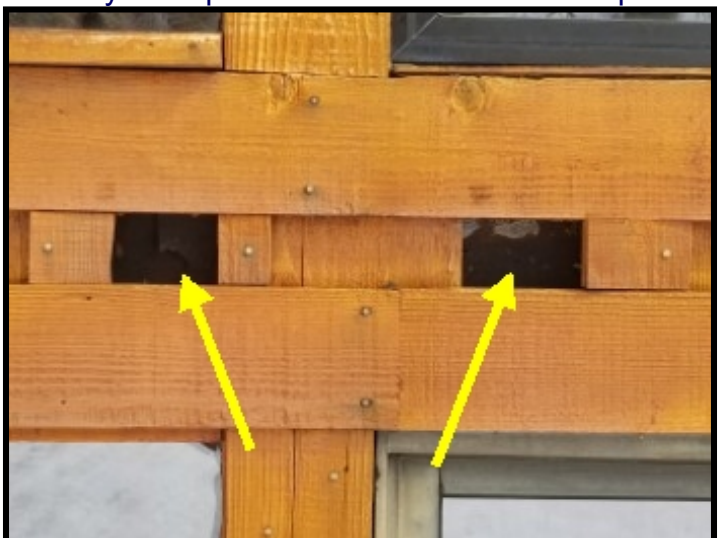
Missing siding on south side of pool

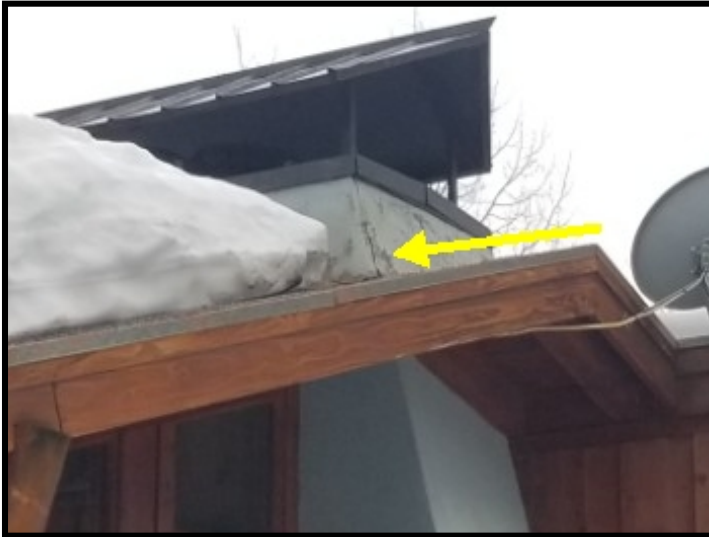
Damaged stucco around chimney

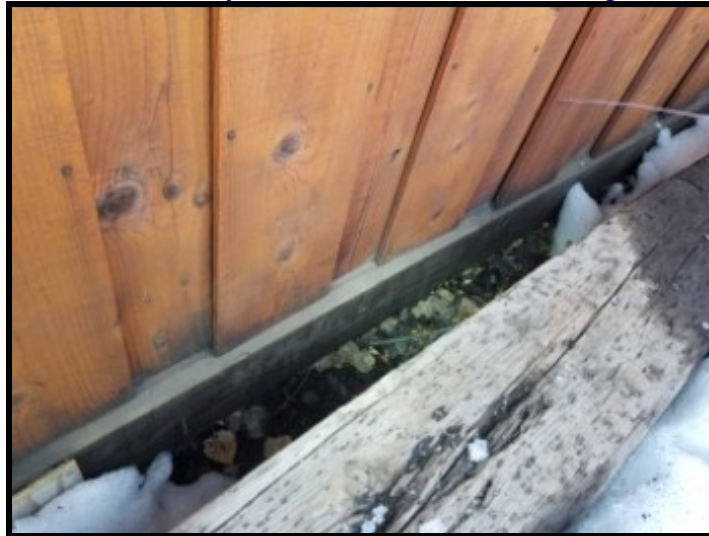
Siding touching dirt on east side of house

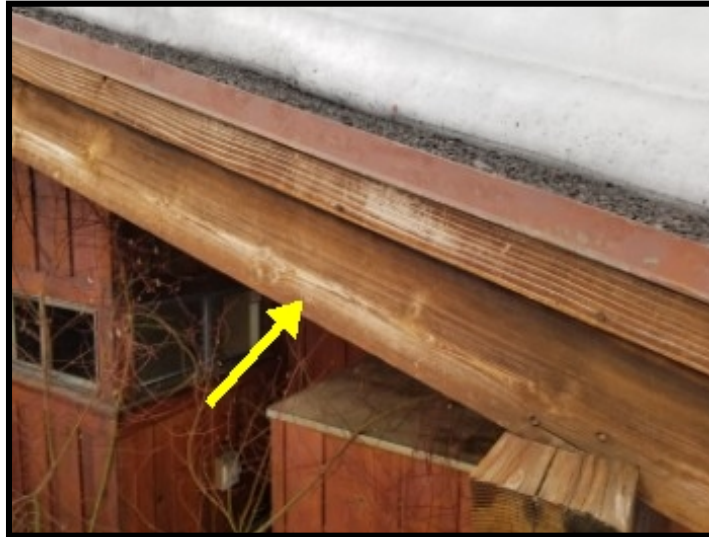
6.1. Recommend restaining fading fascias

Faded fascias

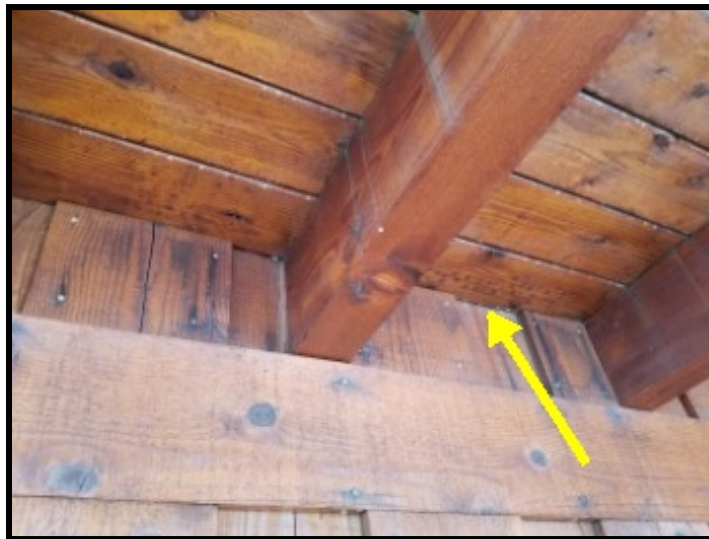
8.1. No flashing observed between west cantilevered deck and siding. Flashing at this location helps prevent moisture from getting behind joists and siding that can cause damage. Recommend repair

No flashing between west deck and siding

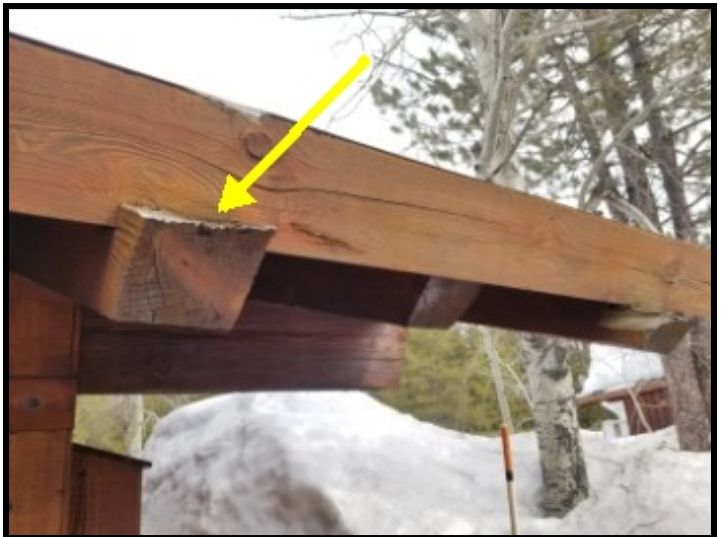
Cracked rafter ends

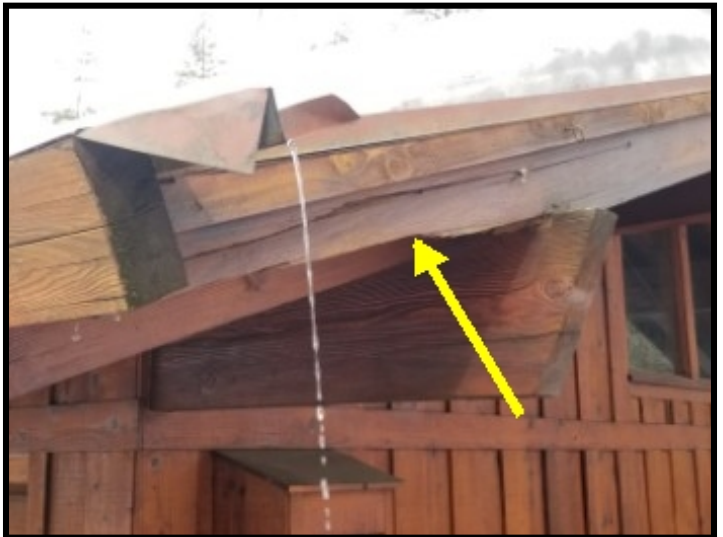
Damaged varge rafter on east end

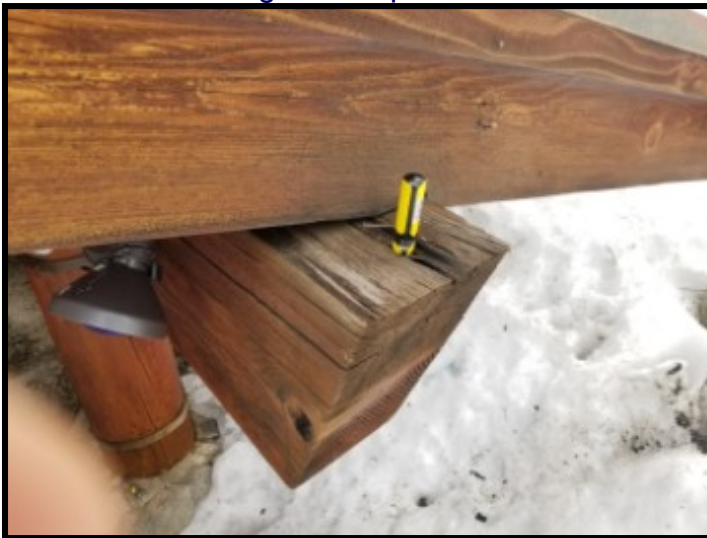
Decay at top of exposed beam on southwest corner of house

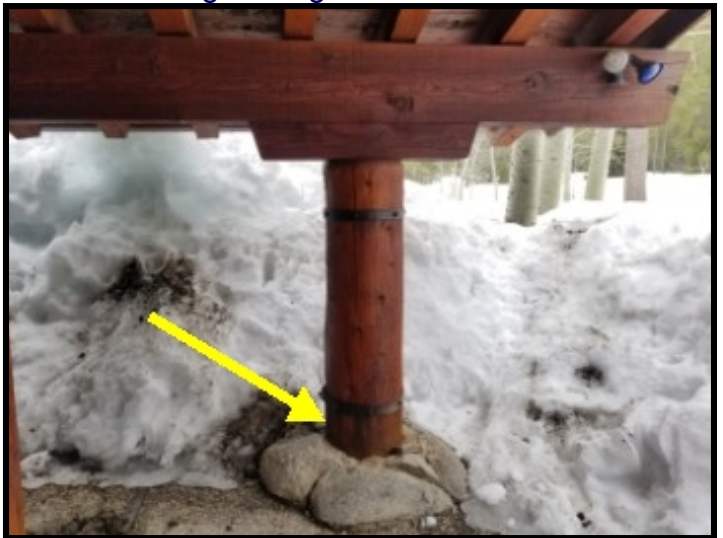
Hollow sounding log post at southwest corner

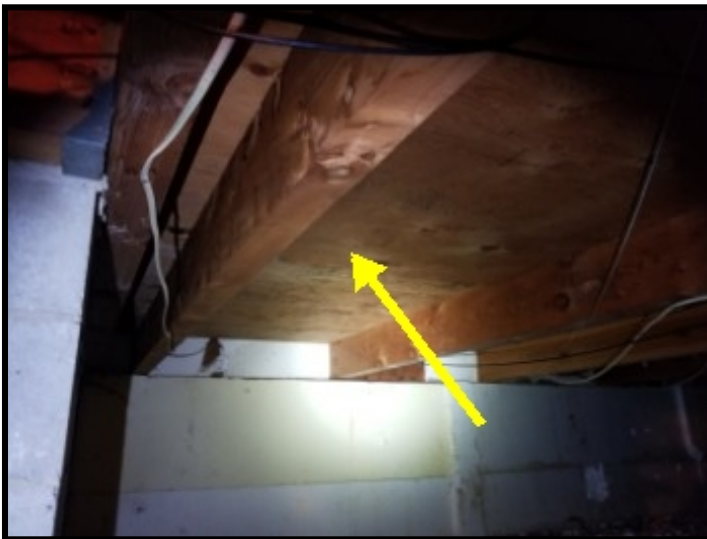
2.1. No insulation was found in the crawlspace in between the floor framing members. Recommend installation of insulation between all framing members to increase the comfort and the efficiency of the home.

No insulation between floor framing

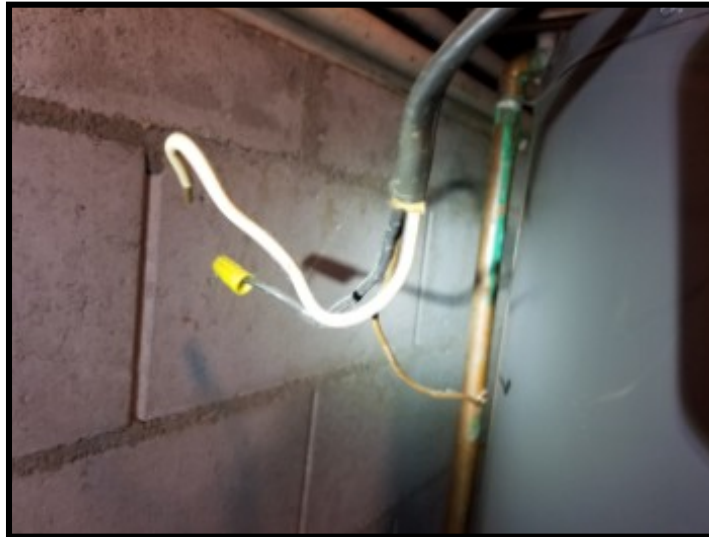
4.1. Exposed hot electrical wires observed near water heater. Recommend capping these for safety

Hot electrical wires

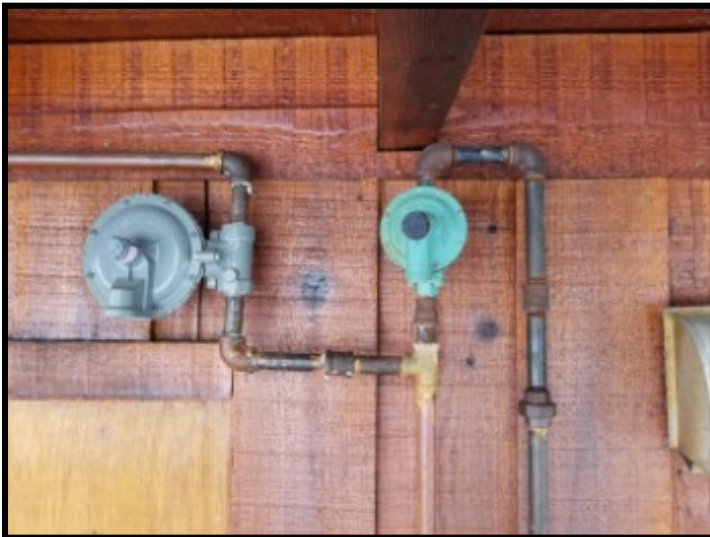
1.2. No gas shut-off observed at one area where gas enters. Shut-off valves are typically near the pressure regulator. Recommend installing for safety

No gas shut-off valve

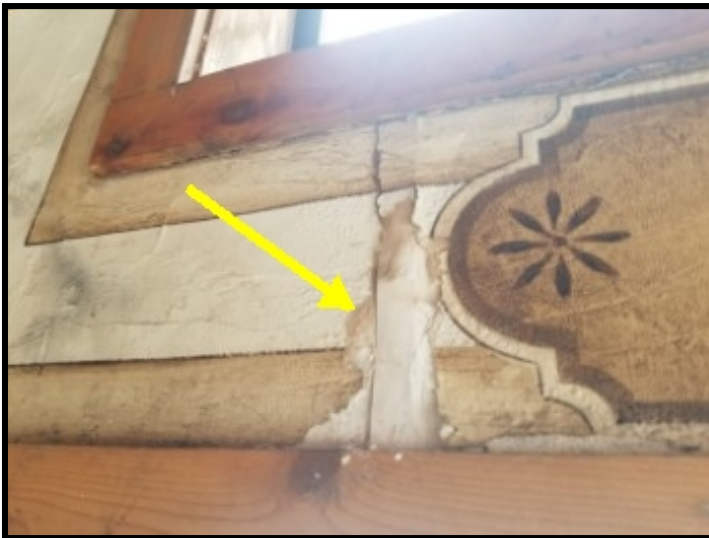
Damaged drywall above patio door

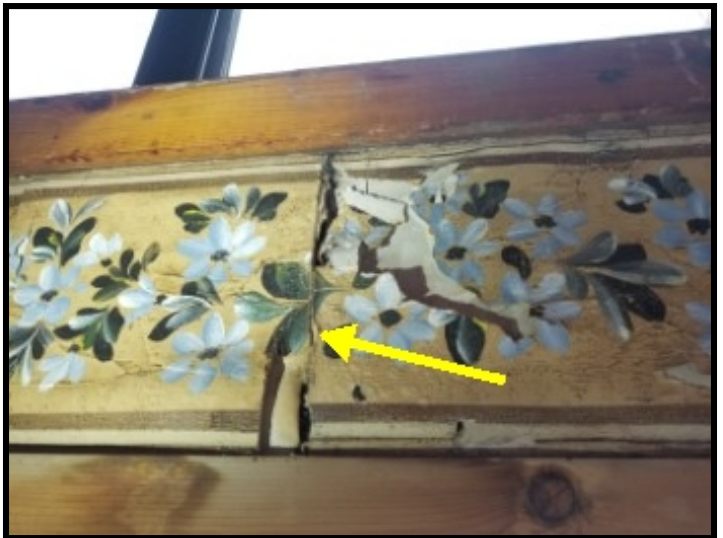
Damaged drywall

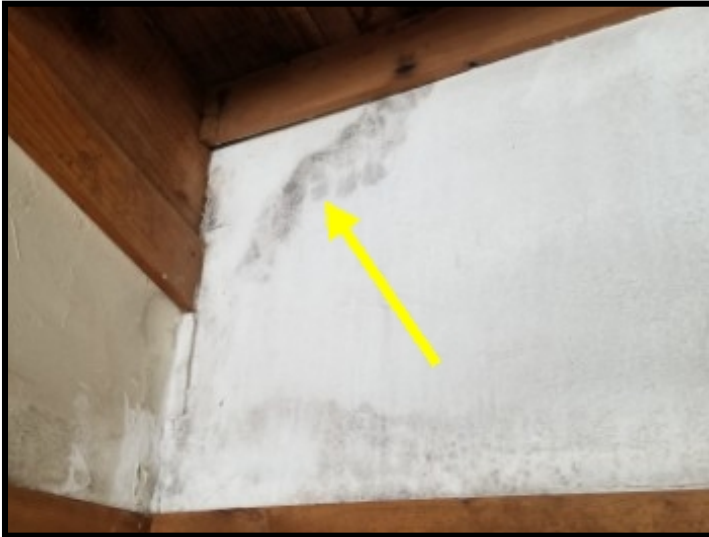
Organic growth on north wall

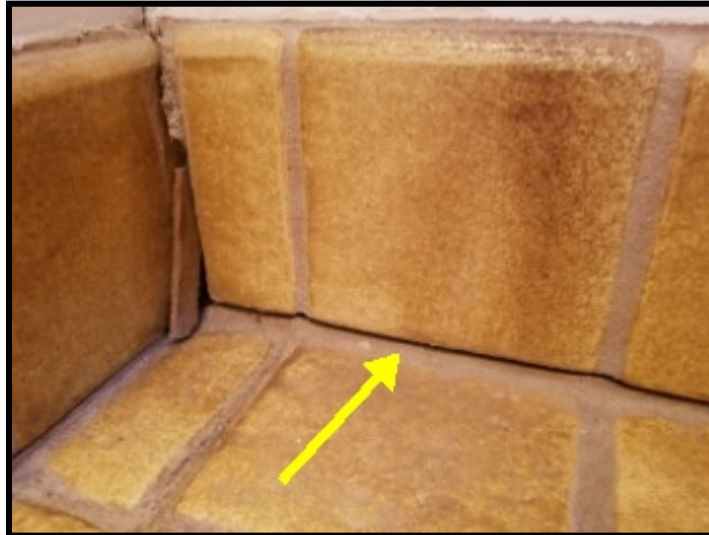
4.1. Cracked grout between tile counter and backsplash

Cracked grout between tile counter and backsplash

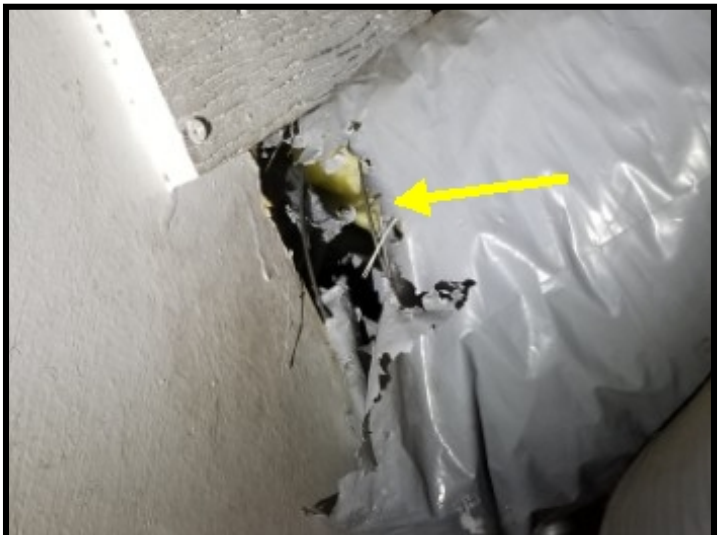
1.1. Damage to several insulated ducts in mechanical room. Contact licensed HVAC contractor for replacement of ducts

Hole in ducting

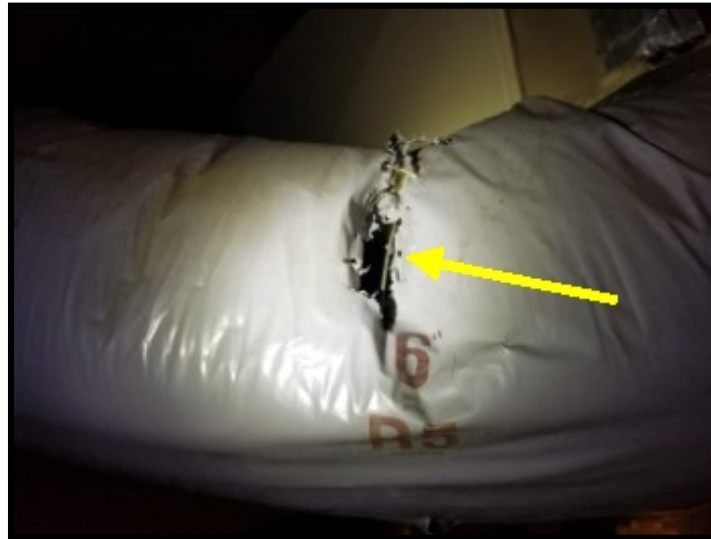
Damaged duct

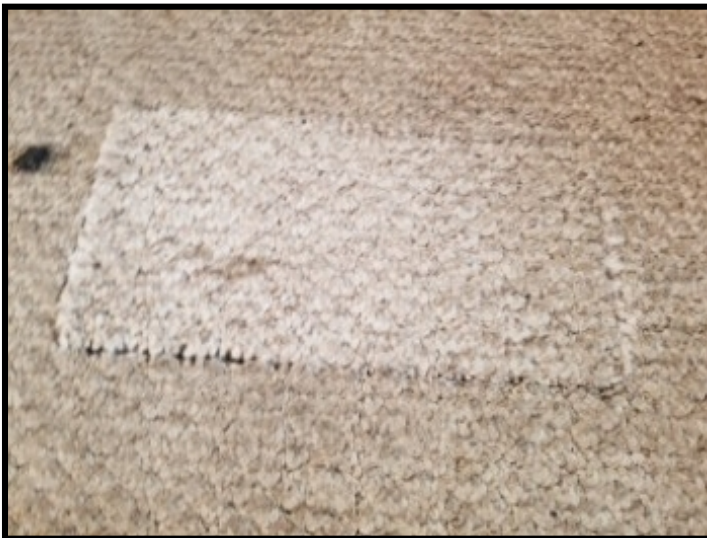
7.1. Repaired carpet at top of stairs and in hallway. Several burn marks in front of fire

Repaired carpet at top of stairs

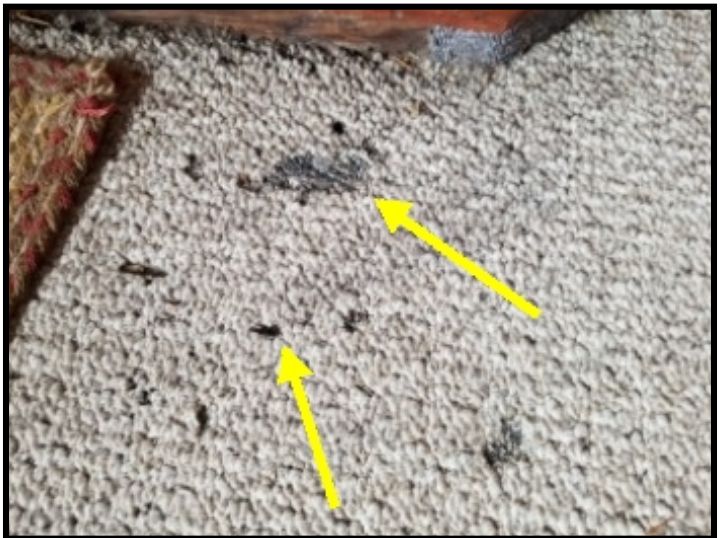
Burn marks

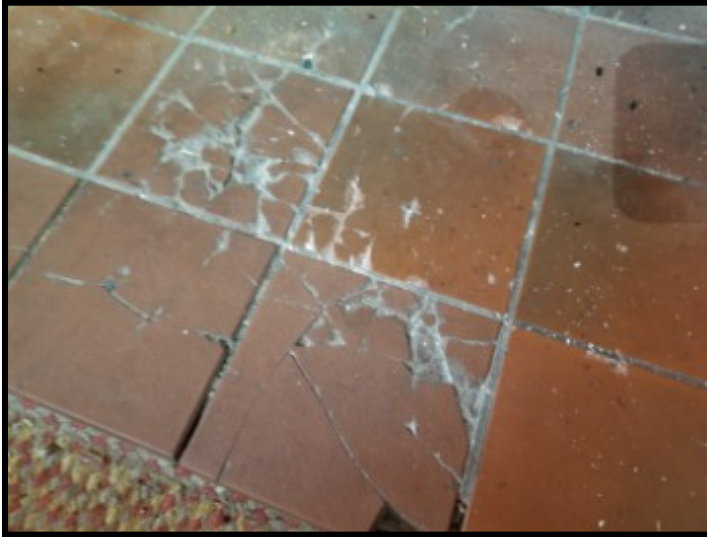
9.3. Cracked and damaged hearth

Damaged hearth

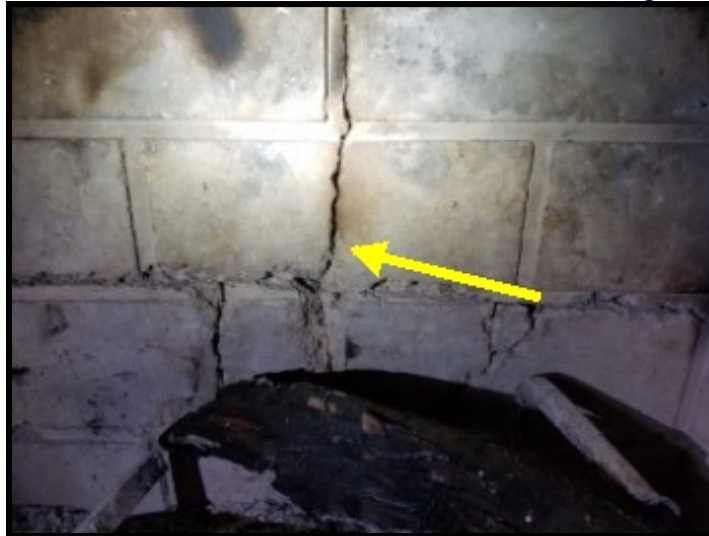
9.2. Damaged fire bricks in fireplace. Recommend replacing fire bricks prior to use

Damaged fire bricks

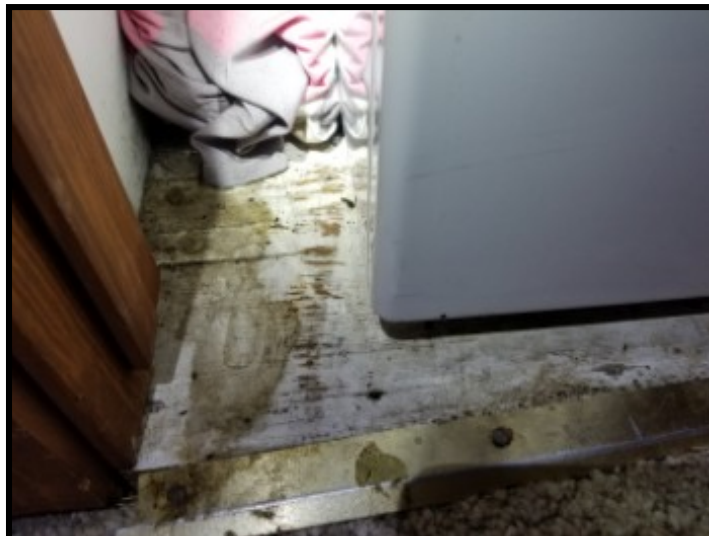
8.1. Wet flooring indicates an active leak. Contact appliance specialist for repair

Wet flooring indicates an active leak

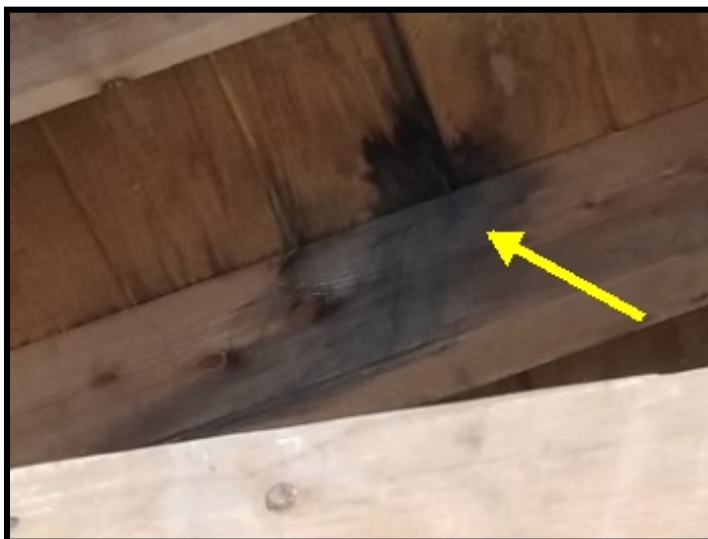
5.3. Water stains on wood framing. Unable to determine if issue has been resolved. Contact seller for more information

Water stains on wood framing

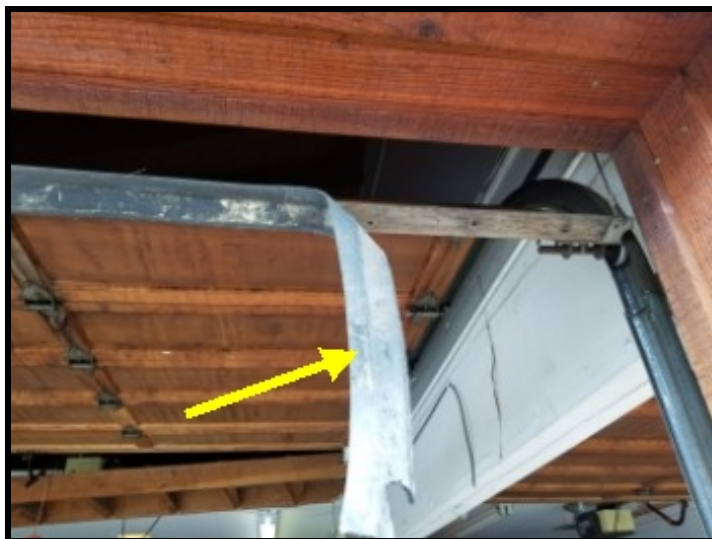
6.1. Loose garage door gasket

Loose garage door gasket

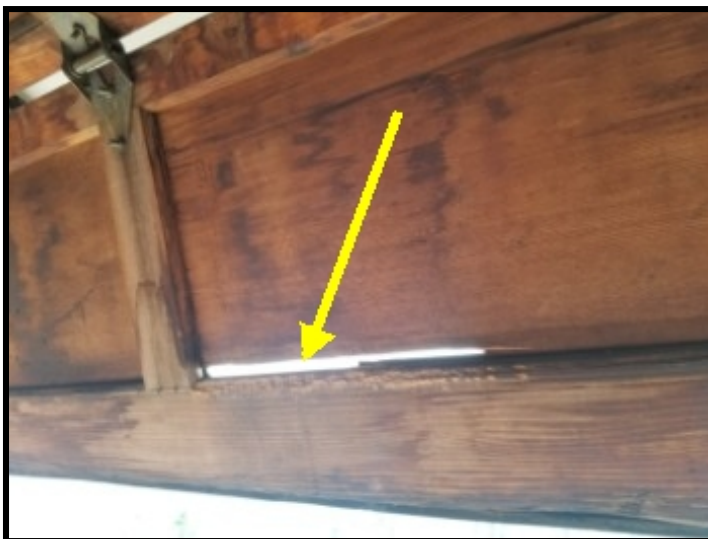
6.2. Damage at bottom of right garage door

Damage at bottom of right garage door

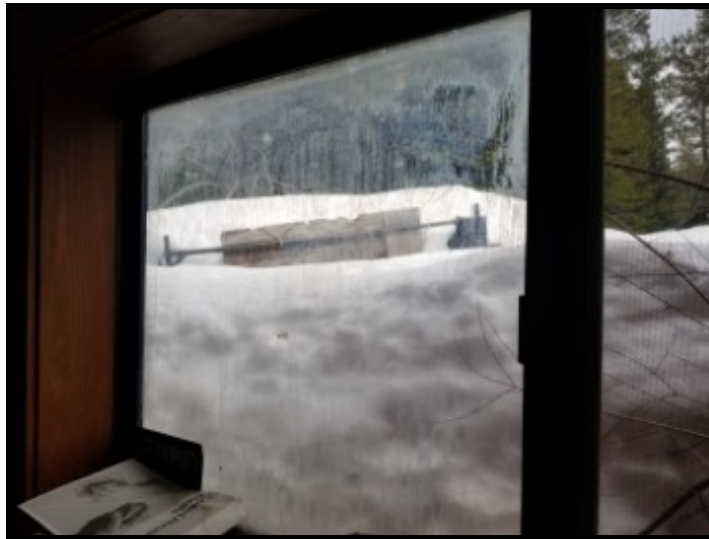
8.1. Cloudiness/condensation observed in double pane window in garage shop. This is an indication of a failed seal. A qualified contractor should review for replacement as needed.

Failed window seal in garage shop

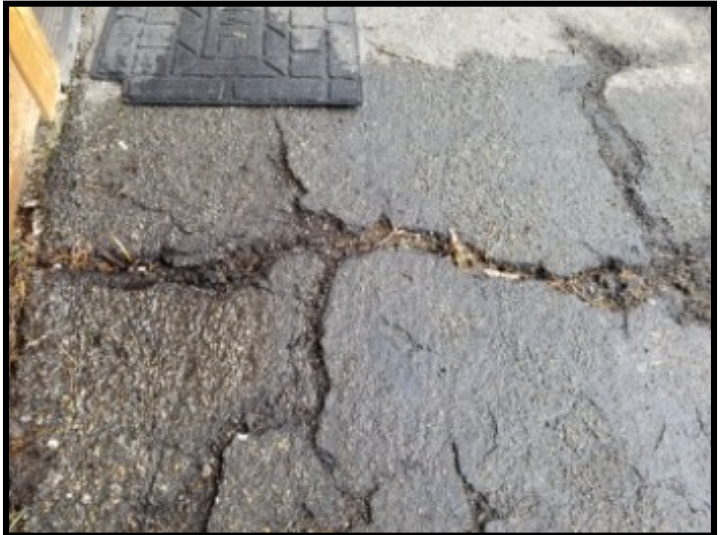
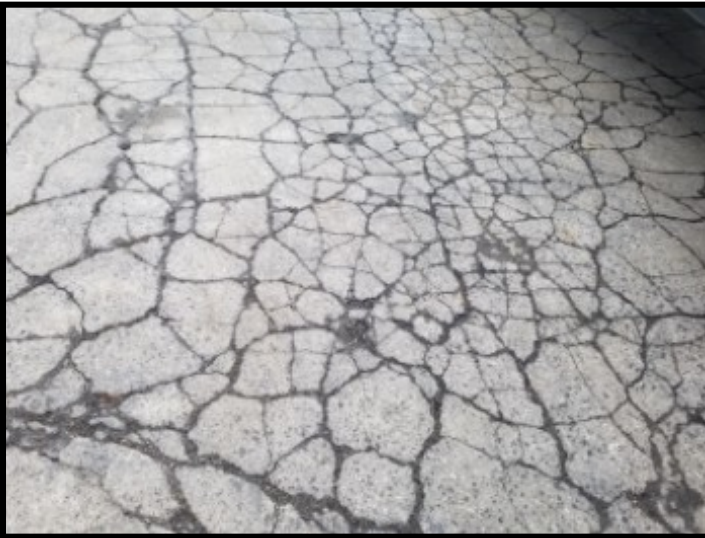
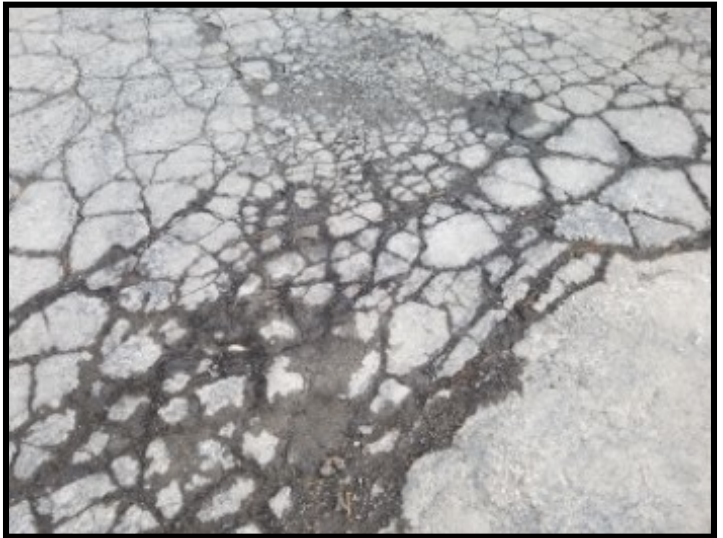
1.1. Moderate cracks and deterioration in driveway. Repair and/or monitor for development trip hazards or further deterioration. Recommend sealing to extend life.
