February 20, 1998

Job S9763

Final Report: Summary of Results Aquifer Testing, Squaw Valley Placer County, California

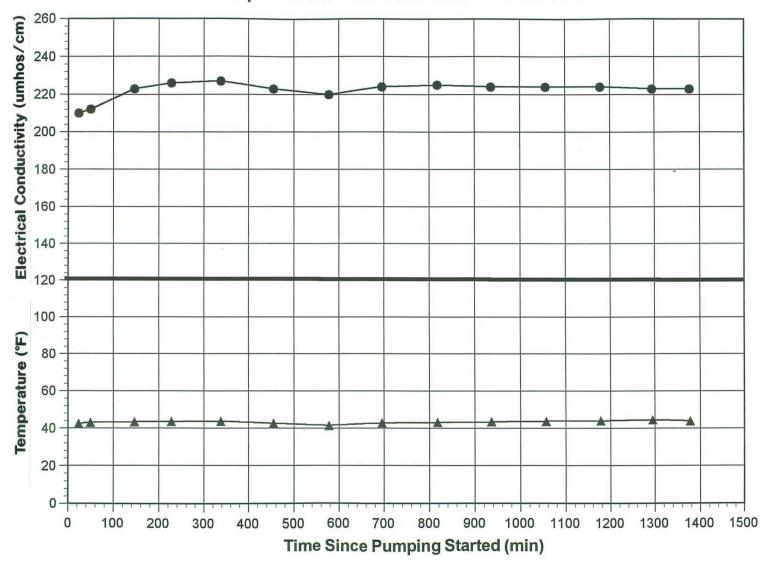
- In Well No. 18-3, the temperature of the groundwater collected during pumping ranged from 42.5°F, at the beginning of the aquifer test, to 43.9°F near the end of the test. The temperature appeared to remain constant during the entire test.
- The EC for water samples collected from the discharge ranged from 210 μ mhos/cm at the beginning of the aquifer test, to 223 μ mhos/cm, near the end of the aquifer test. The EC measurements appeared to stabilize after approximately 630 minutes (approximately 16½ hours).

FIGURE 16
Field Water Quality Measurements
Squaw Creek Resort Golf Course Well No. 18-3

Well No. 18-3 differed significantly from that in the creek, indicating that the creek did not recharge, and hence did not impact the pumping water levels in Well No. 18-3 during this 23-hour pumping period.
