Property Inspection Report

325 Squaw Valley Rd, Olympic Valley, CA 96146

Date of Inspection: 4/4/2019 Time: 9:00 AM

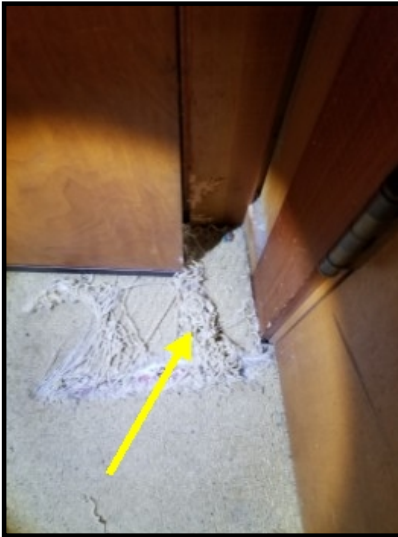
9.1. Normal wear observed for the age of flooring

Ripped carpet in trophy room

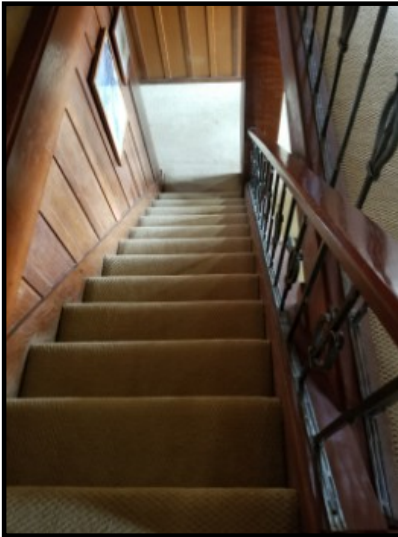
10.1. No graspable handrail at stairs. Common construction practice is to provide a graspable handrail on one side of the stairs.

No graspable handrail at stairs

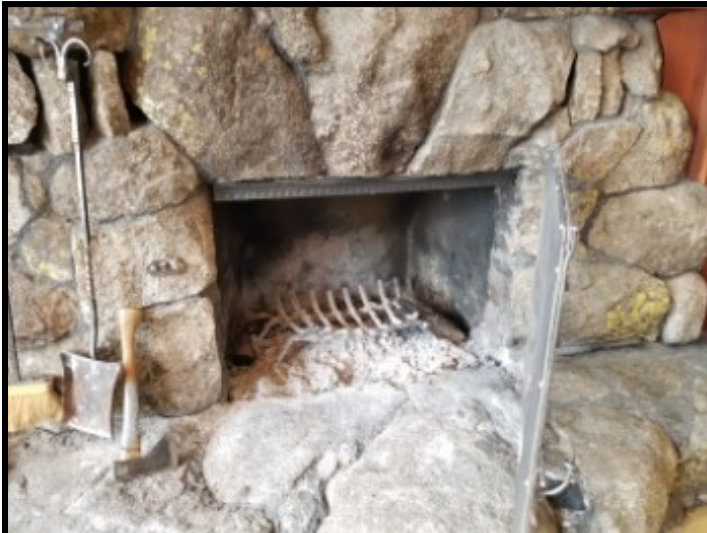
11.2. Warped firebox in living room fireplace. Monitor for further warping or damage and consult fireplace specialist if needed

Wood burning fireplace in living room

11.1. Recommend sweeping chimney before use and annually to ensure safe operation.

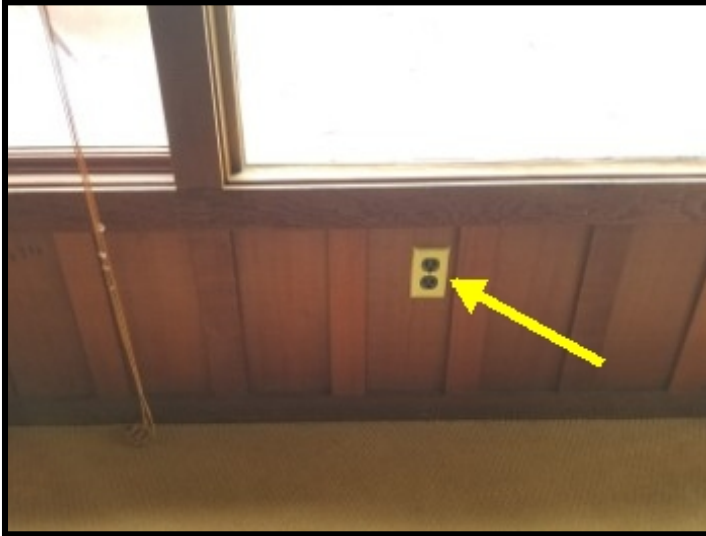
1.3. No power to outlet below window in master bedroom

No power to outlet below window in master bedroom

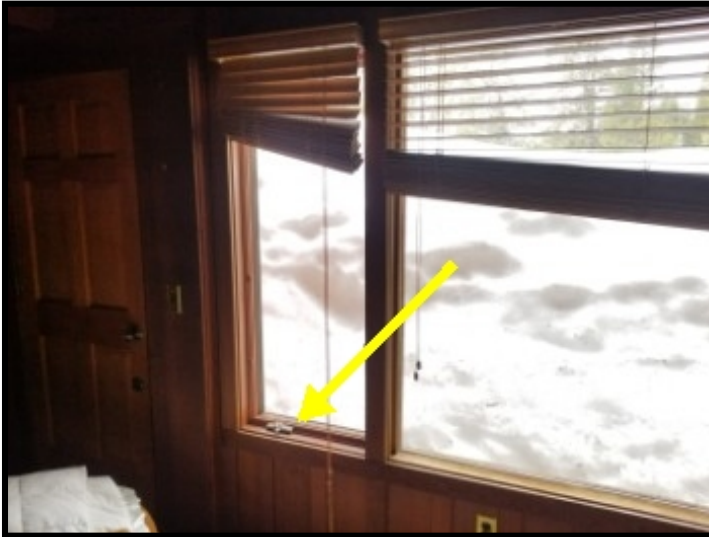
Stripped window opener in master bedroom

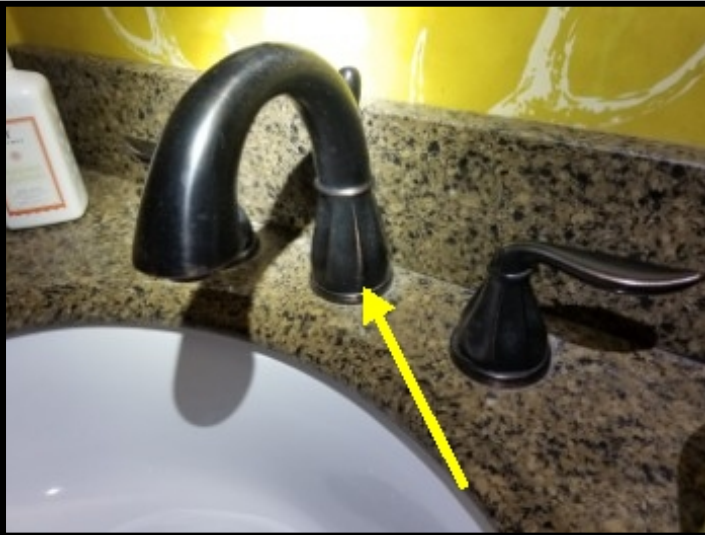
5.2. Fixture is loose on sink basin in entry level guest bathroom. Recommend tightening

Fixture is loose on sink basin in entry level guest bathroom

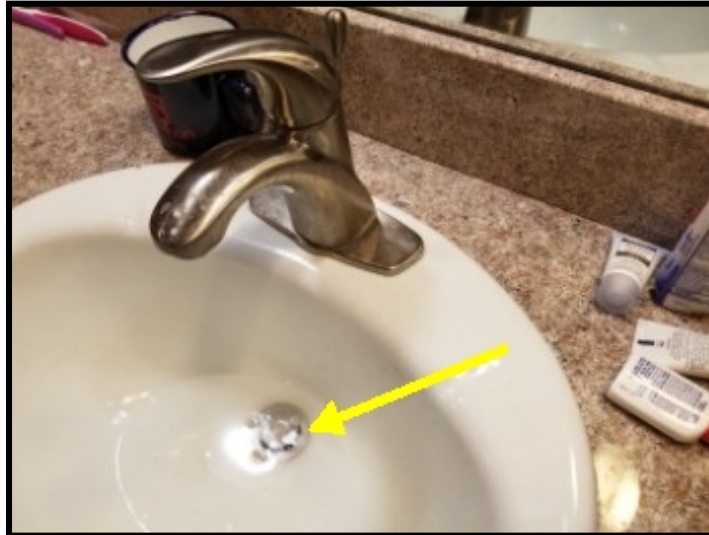
Sink stopper is inoperable in upstairs guest bathroom

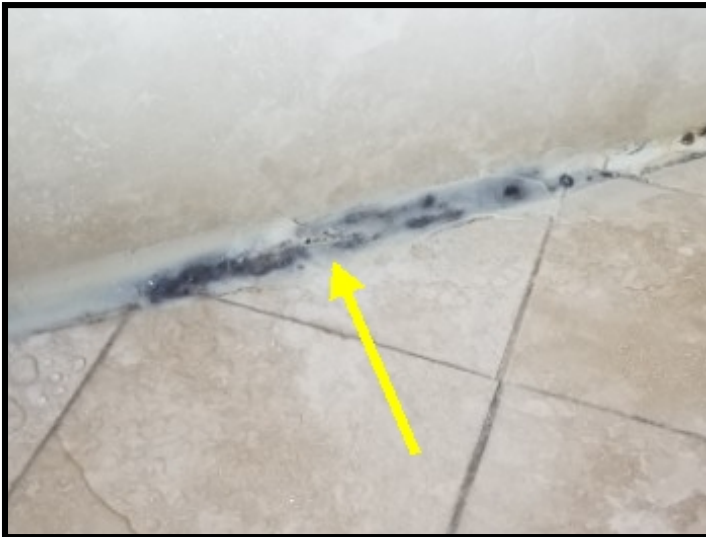
6.1. Fungus observed on upstairs guest bathroom shower caulk. Recommend removing caulk and regrouting

Remove caulk and regROUT in upstairs guest bathroom shower

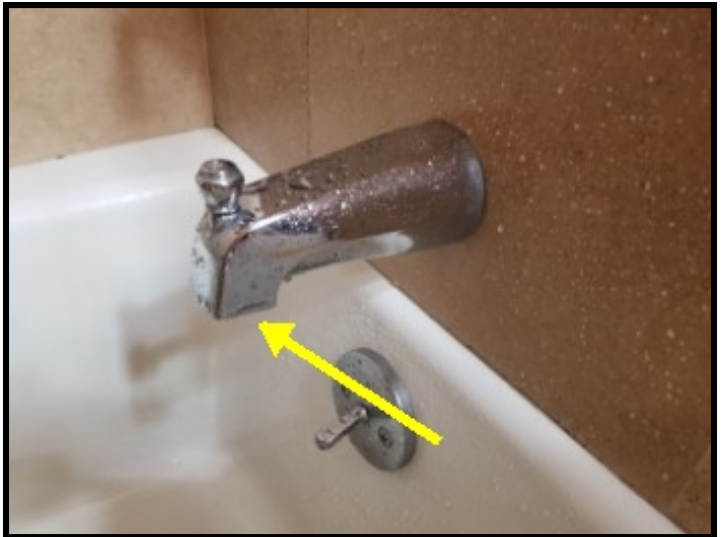
6.2. Water comes out of upstairs ensuite bathroom tub spout after diverter valve is engaged. Contact licensed plumbing contractor for further evaluation and repair.

Water comes out of upstairs ensuite bathroom tub spout after diverter valve is engaged

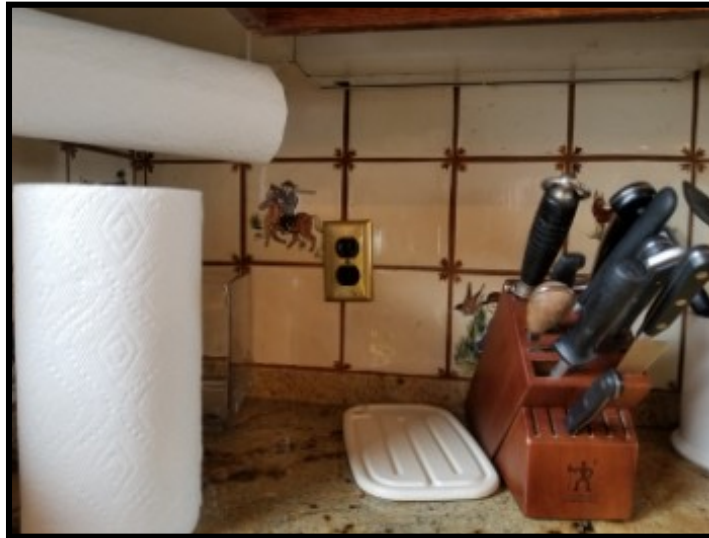
2.1. Some outlets are not GFCI protected. Suggest installing GFCI protection at all receptacles for safety.

Most outlets in kitchen not GFCI protected

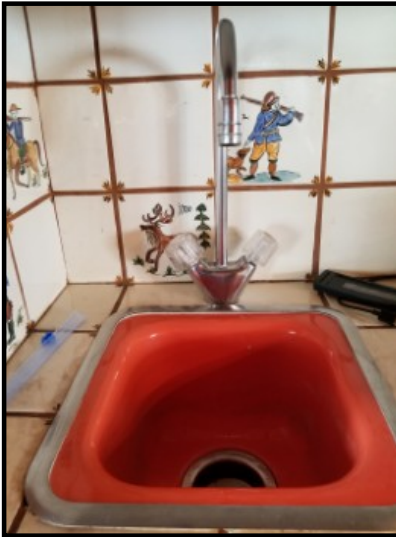
kitchen bar sink

5.2. Cold water does not work in bar sink

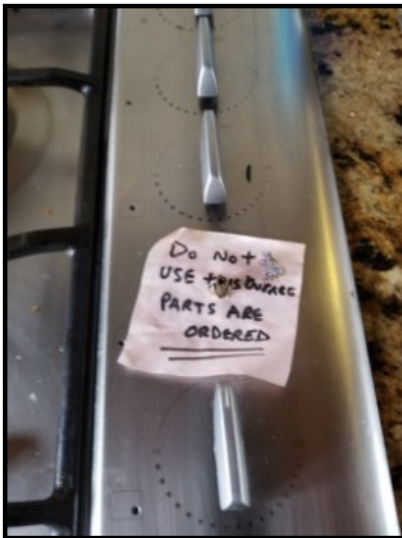
8.3. The cook top is missing some temperature control knobs

Missing knob on cooktop

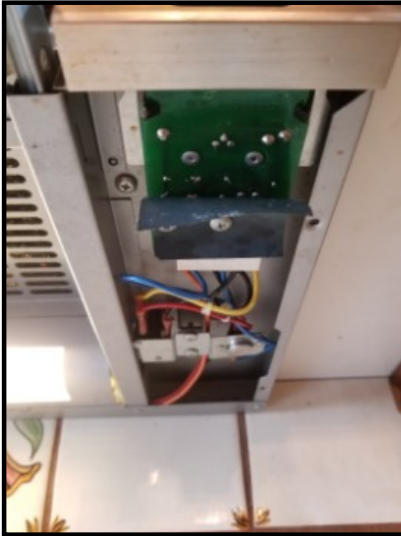
10.2. Kitchen exhaust fan missing electrical cover

Kitchen exhaust fan missing electrical cover

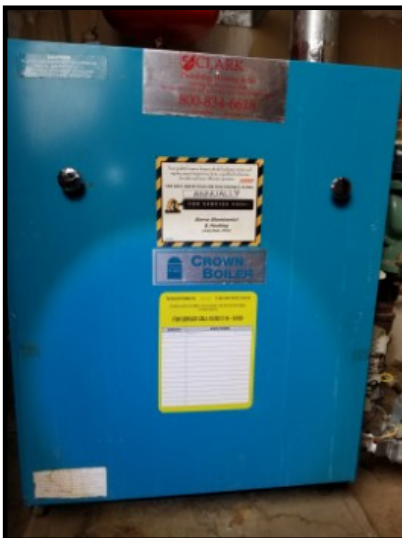
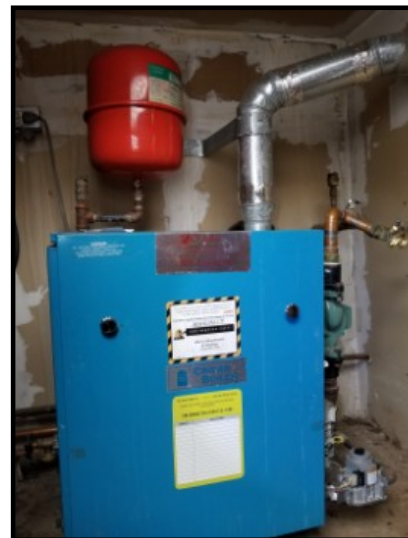
Main House boiler

1.1. Crown Boiler manufactured in 1996 per serial number or label. The average lifespan of a furnace is 20 years. This unit may be near the end of its effective life. Recommend replacing with a more efficient unit.

1.2. Heating system did not heat house in an adequate amount of time. Recommend further evaluation by licensed HVAC contractor.

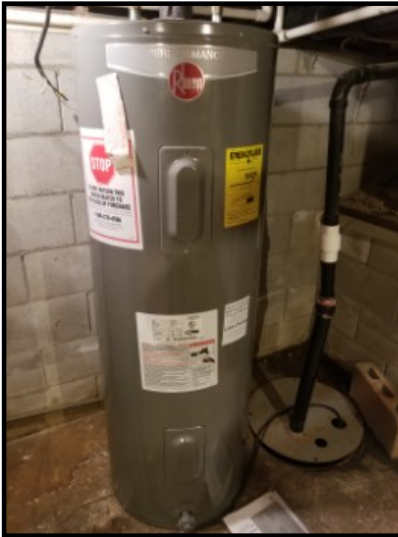
Water heater in main house

1.3. No **expansion tank** installed at water heater. An expansion tank prevents damage to valves, pipes, and the water heater by allowing a place for water to go when it expands from being heated. Contact a licensed plumbing contractor for installation

1.4. The water heater is not strapped. Two straps, 1/3 from the top and the bottom, required.

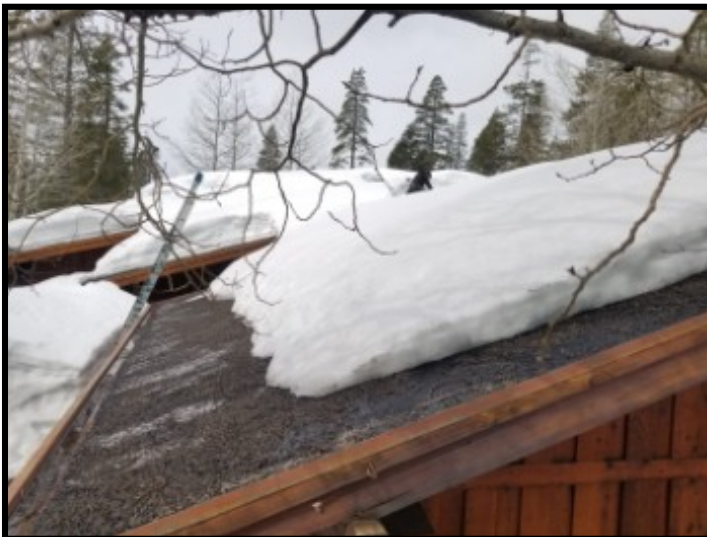
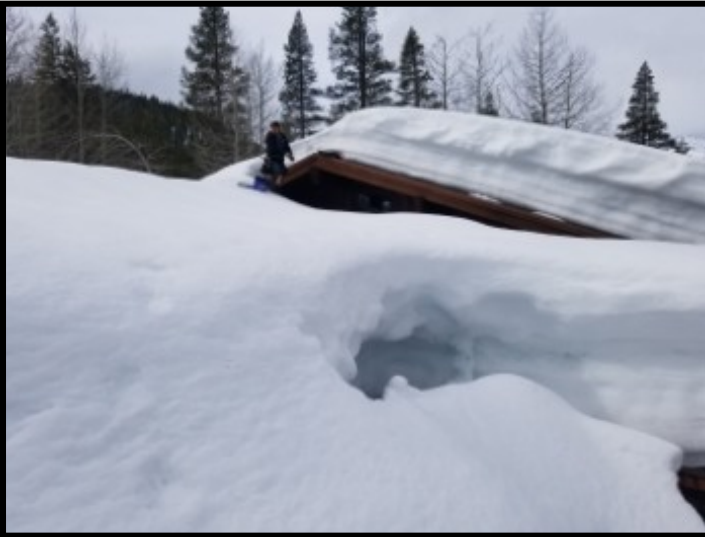
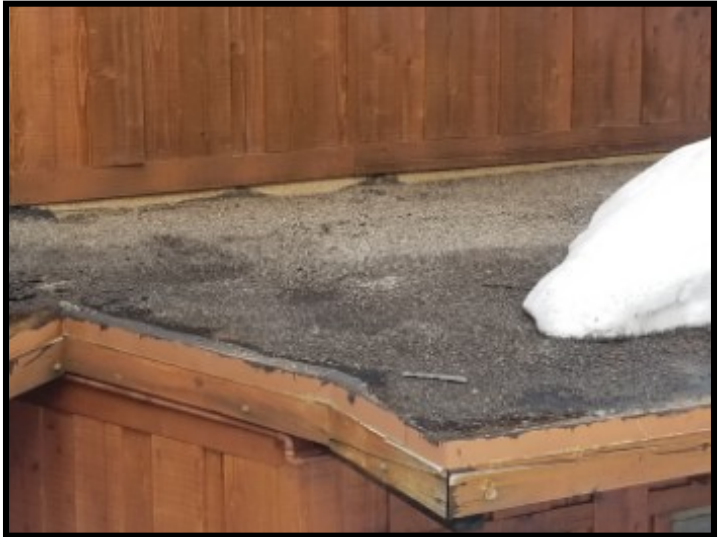
1.1. Roof was mostly snow covered at the time of inspection. These areas of the roof were unable to be inspected

Snow covered roof

Snow covered most of roof

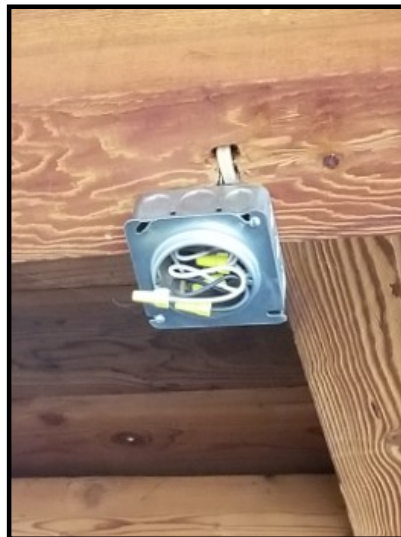
1.1. Open junction box in garage

Open junction box in garage

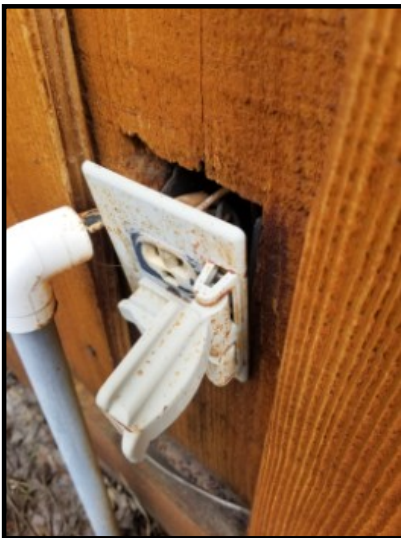
- 4.1. All exterior outlets in weatherproof covers and are GFCI protected
- 4.2. Loose electrical outlet on south side of pool building. Repair for safety
- 4.3. Exposed electrical wires above boiler enclosure. Recommend enclosing wires in junction box for safety

Loose outlet on south side of pool building

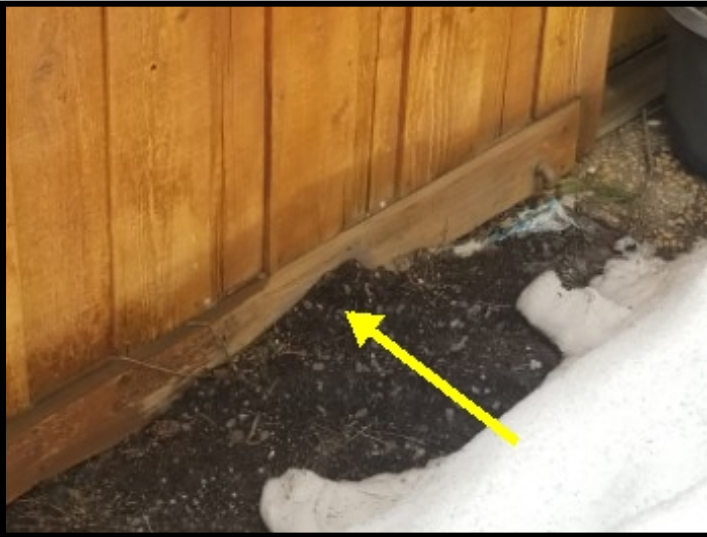
- 5.1. Some areas need restaining.
- 5.2. Some areas were unable to be inspected due to snow sitting against siding
- 5.3. Bird damage observed in several areas of siding
- 5.4. Siding is in contact with soil. 6" clearance (between wood and soil) is recommended to prevent moisture damage.
- 5.5. Missing siding boards, exposing vapor barrier. Repair siding
- 5.6. Cracked and damaged stucco around chimney above and below roof. Recommend repair

Small amount of dirt touching siding

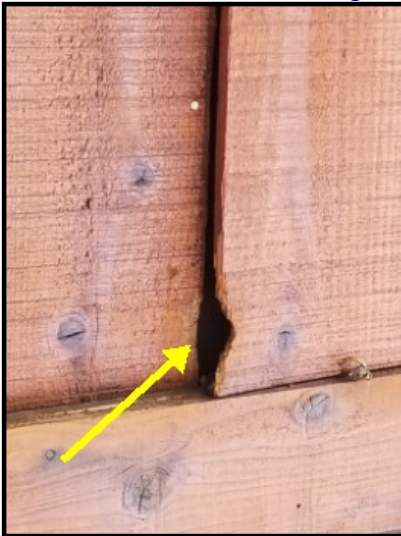
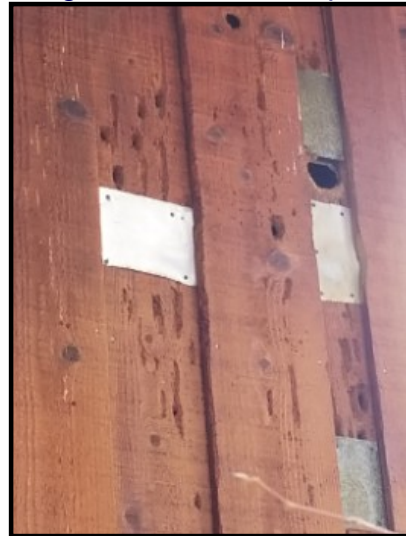
Bird damage on west side

Many woodpecker holes on west side of pool

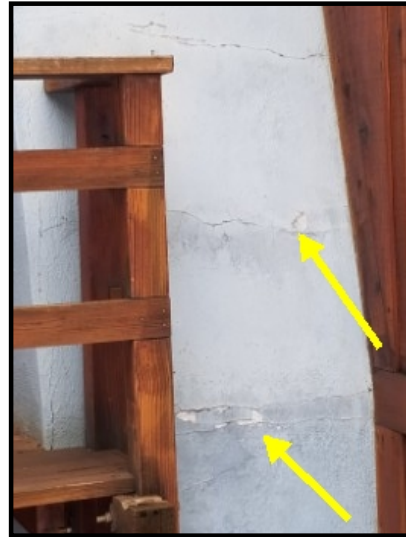
Damaged stucco on chimney

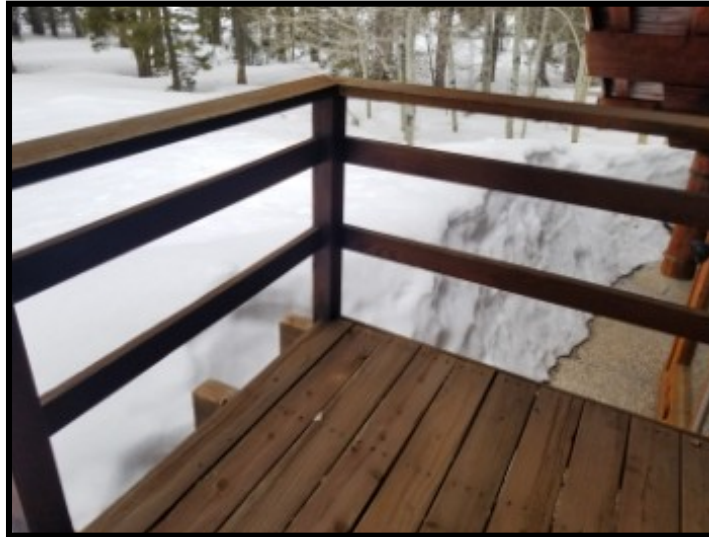
9.1. Baluster spacing exceeds the 4 inch spacing which is considered safe by today's child safety standards. At the time this house was constructed, this was not the building code requirement.

Wide spacing at deck railing

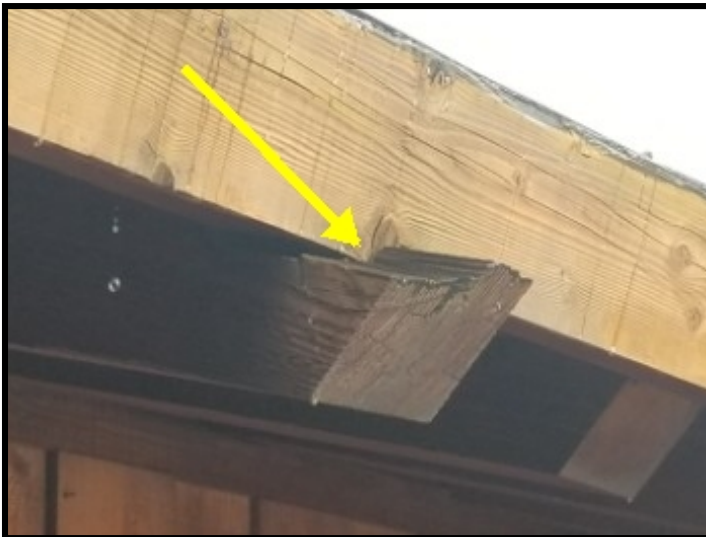
- 10.1. Cracked rafter ends around edge of house. These should not affect the integrity of the roof.
- 10.2. Wood decay observed at tops of some exposed outlooker beams. Contact licensed general contractor for repair or to cut off all exposed ends. Recommend installing metal flashing over exposed beams and rafters to prevent any other beams from rotting
- 10.3. Damaged verge rafter on east end of house. Recommend replacing
- 10.4. Log post supporting roof over southwest patio may be decayed near base. Hollow sound when tapped and total penetration of screwdriver. Recommend further evaluation by licensed general contractor and possible replacement

Cracked rafter end

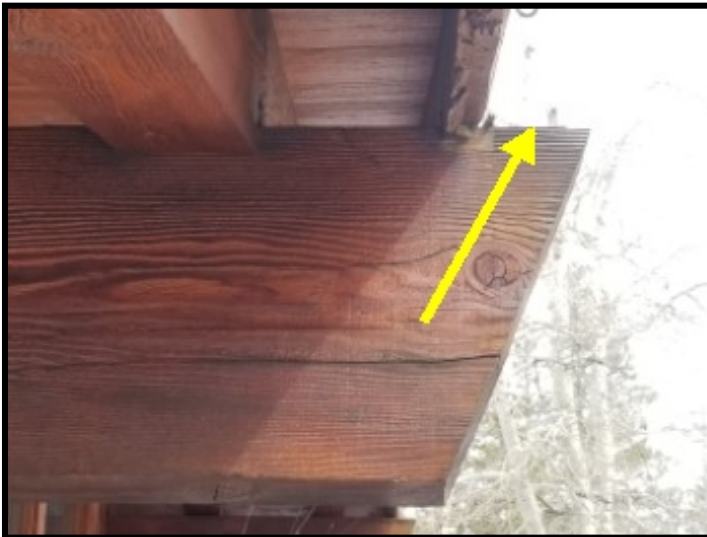
Install flashing over exposed beam ends

Page 28 Item: 10	Exterior Structure	10.2. Wood decay observed at tops of some exposed outlooker beams. Contact licensed general contractor for repair or to cut off all exposed ends. Recommend installing metal flashing over exposed beams and rafters to prevent any other beams from rotting 10.3. Damaged varge rafter on east end of house. Recommend replacing 10.4. Log post supporting roof over southwest patio may be decayed near base. Hollow sound when tapped and total penetration of screwdriver. Recommend further evaluation by licensed general contractor and possible replacement
<u>Main House</u> Foundation/ Crawlspace

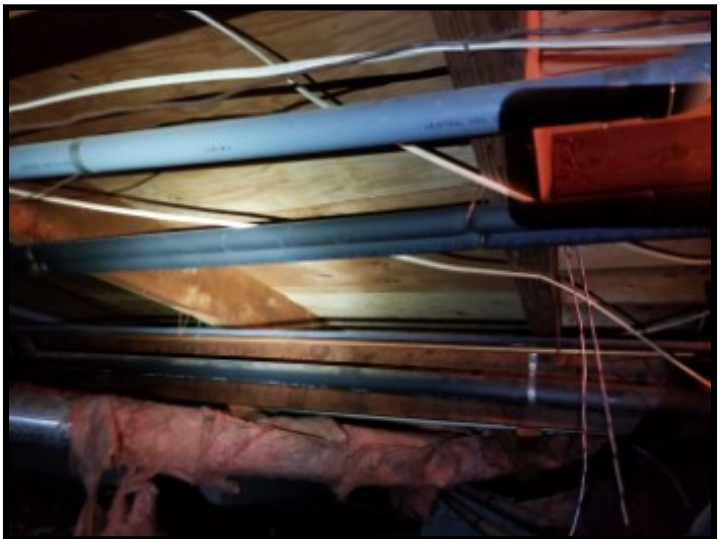
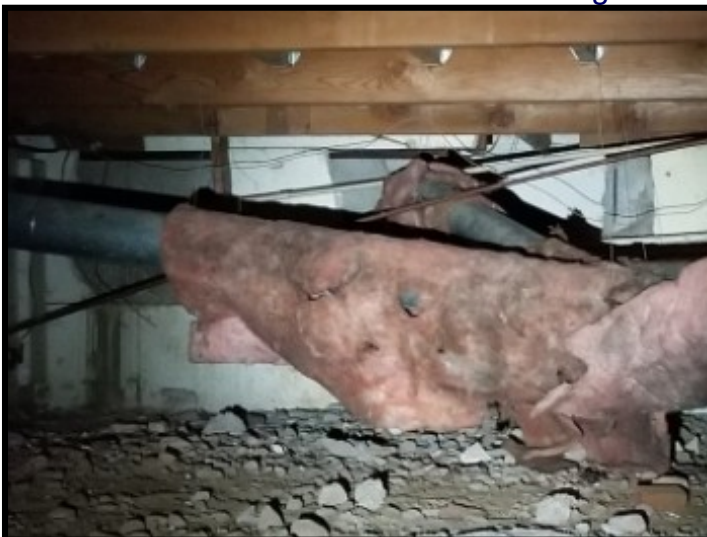
Insulation falling off heating ducts

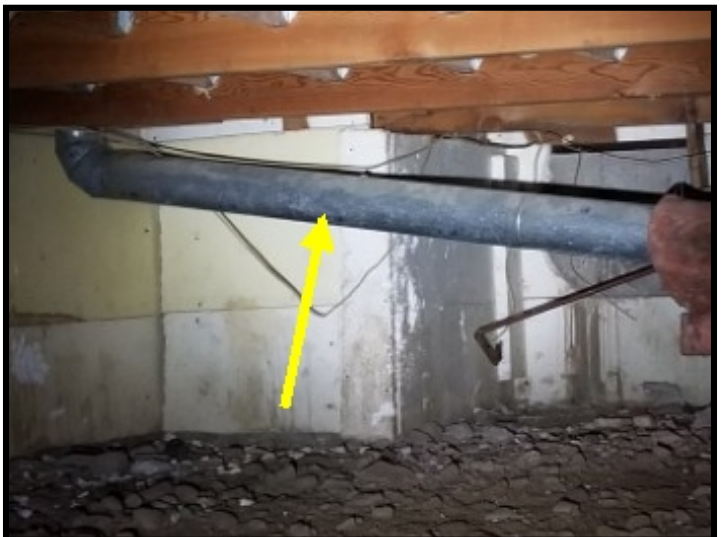
No insulation on some ducts

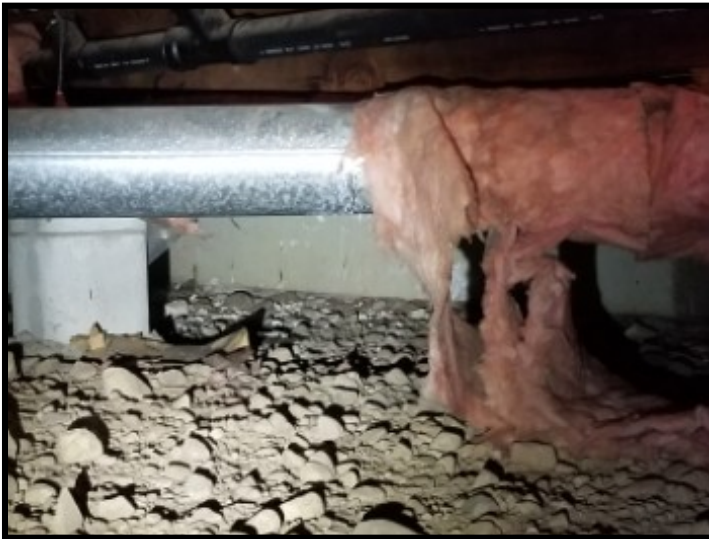
2.2. Insulation on heating ducts in crawlspace is falling off in areas and missing in other areas. Recommend installing and/or repairing insulation on heating ducts to decrease heat loss and increase the efficiency of the heating system.

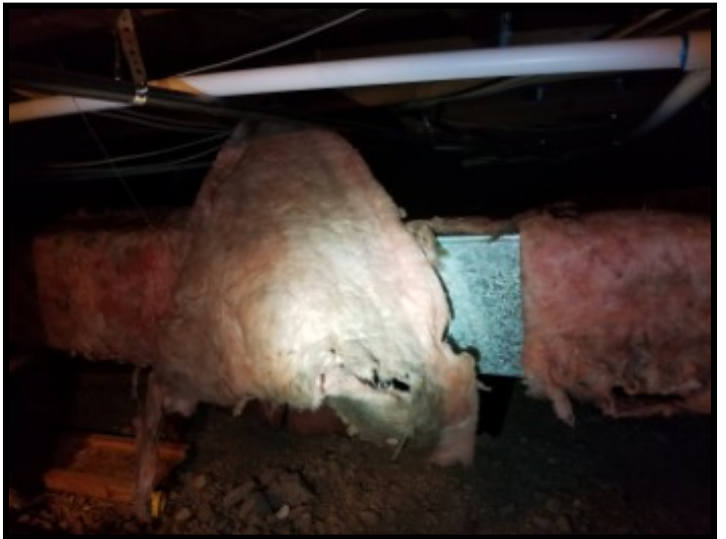
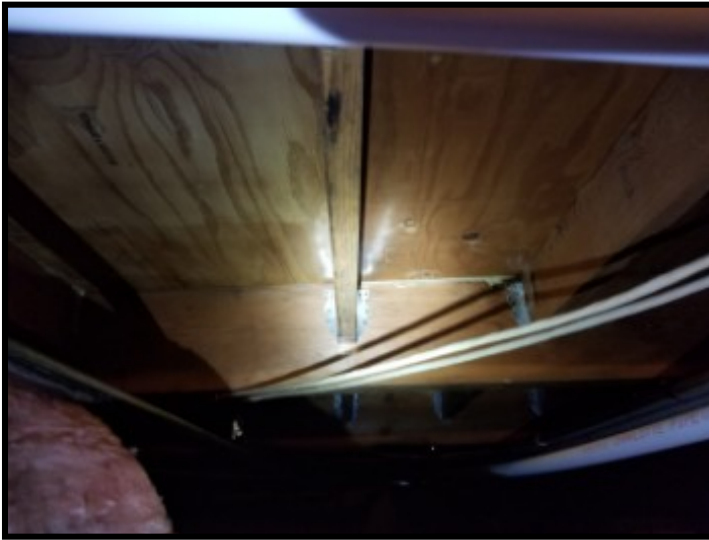
2.1. No insulation was found in the crawlspace in between the floor framing members. Recommend installation of insulation between all framing members to increase the comfort and the efficiency of the home.

No insulation between framing members

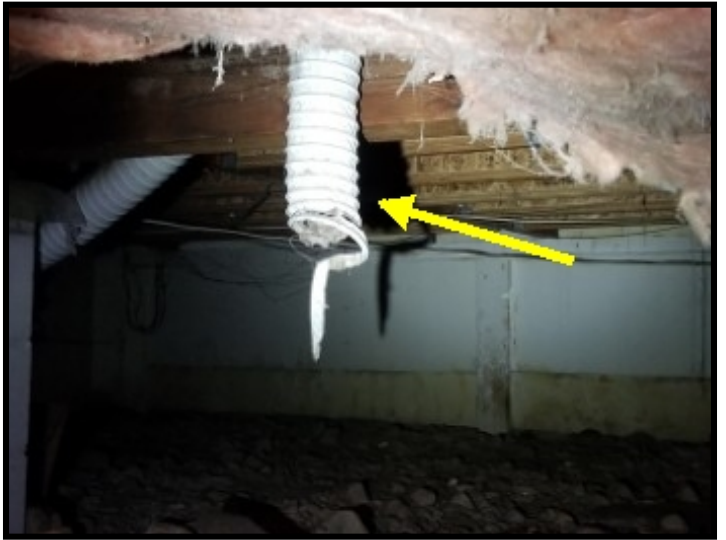
2.3. Dryer exhaust duct terminates in crawlspace. Dryer duct should extend to exterior to prevent hot moist air from entering crawlspace

Dryer exhaust duct terminates in crawlspace

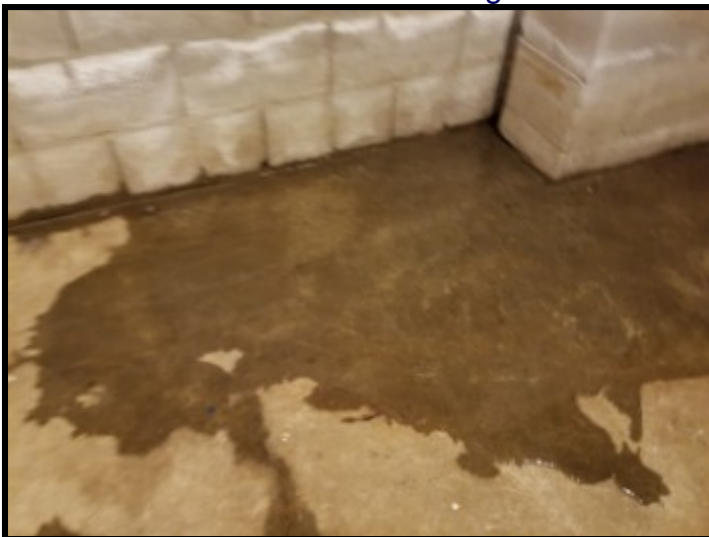
Standing water in crawlspace

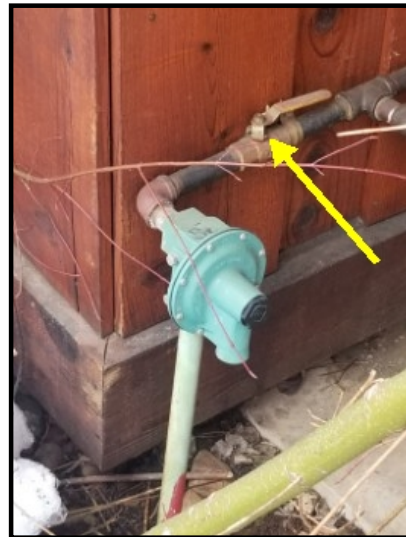
1.2. No gas shut-off observed at one area where gas enters. Shut-off valves are typically near the pressure regulator. Recommend installing for safety

No gas shut-off valve

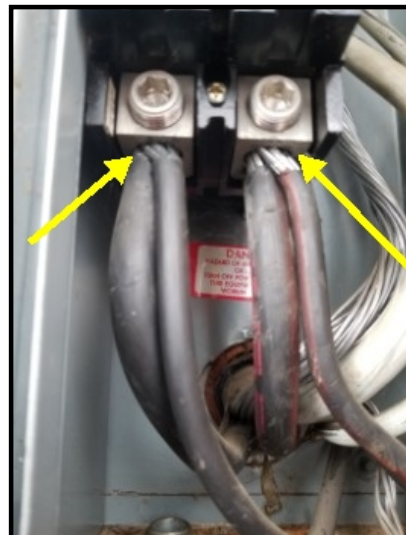
2.3. Double tapped main breaker and double tapped neutral lug connection. Smaller gage wires connected to main breaker are a fire hazard. Contact licensed electrical contractor for repair.

Double tapped breaker in main panel

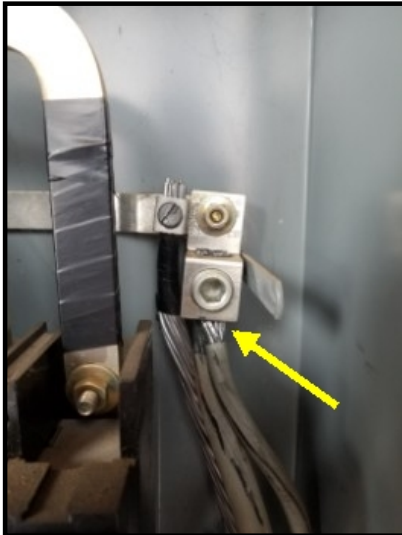
Double tapped neutral lug in main panel

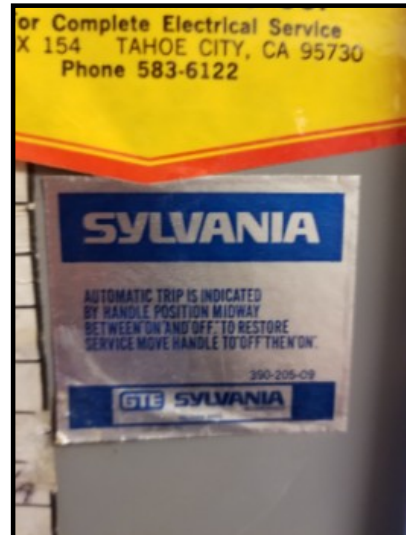
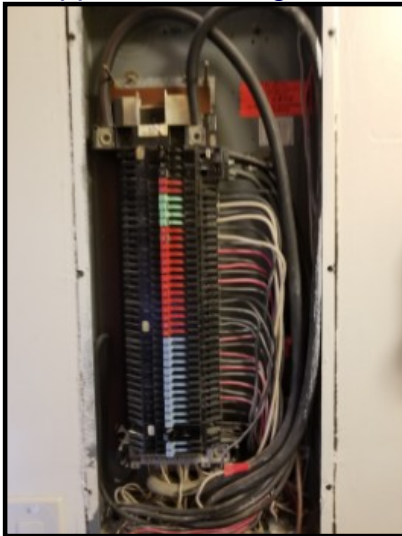
2.4. Laundry room sub panel is a Zinsco Sylvania electrical panel. Sylvania electrical equipment is considered obsolete, due to a design flaw in which the circuit breaker's connection becomes loose, causing arcing and subsequent overheating. Long term exposure to this heat can cause the breaker's contacts to fuse together, thus preventing the breaker from tripping even in an overcurrent situation, thereby causing a potential fire hazard. Recommend replacing electrical panel by a licensed electrician.

Sylvania sub panel

Zinsco Sylvania sub panel

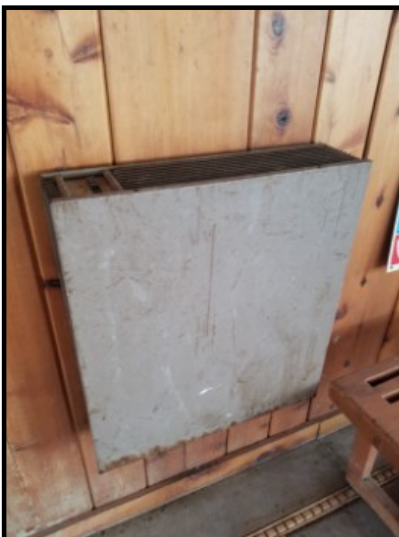
- 1.1. Electric wall heater on east wall did not operate
- 1.2. Ungrounded outlets on east wall. This is an unsafe condition. Contact licensed electrical contractor for repair

Heater did not operate

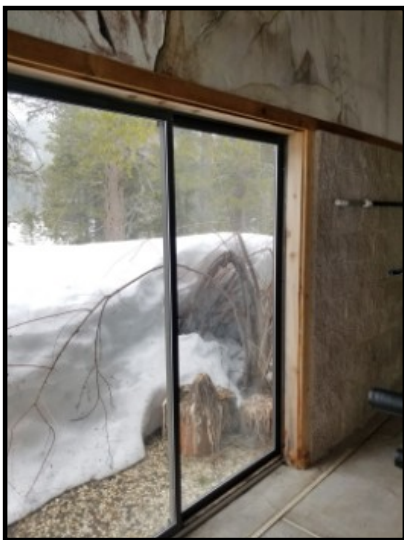
3.1. Cloudiness/condensation observed in double pane windows and sliding patio door in pool room. This is an indication of a failed seal. A qualified contractor should review for replacement as needed.

Failed seal in patio door

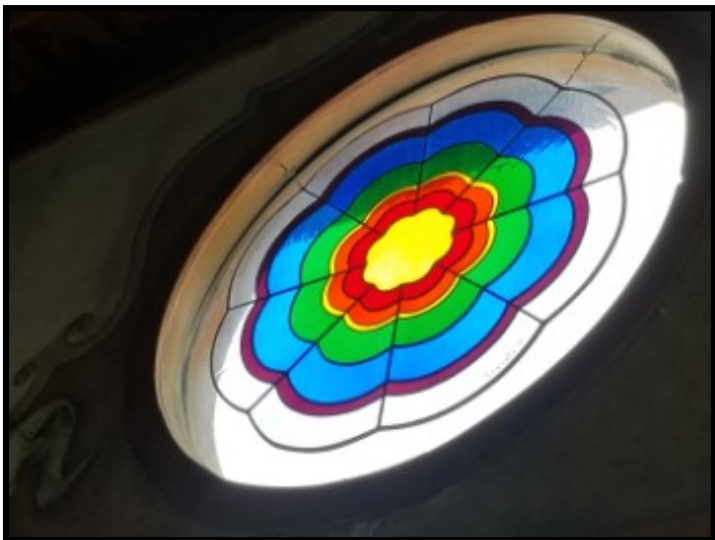
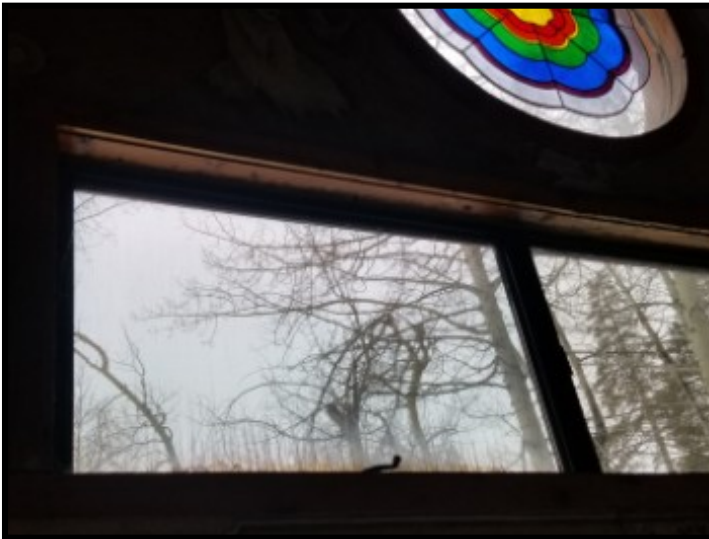
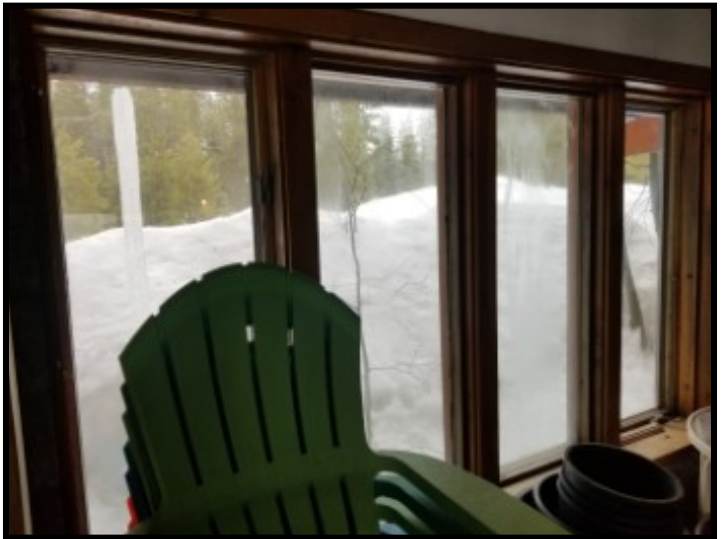
Failed window seal

Failed window seals

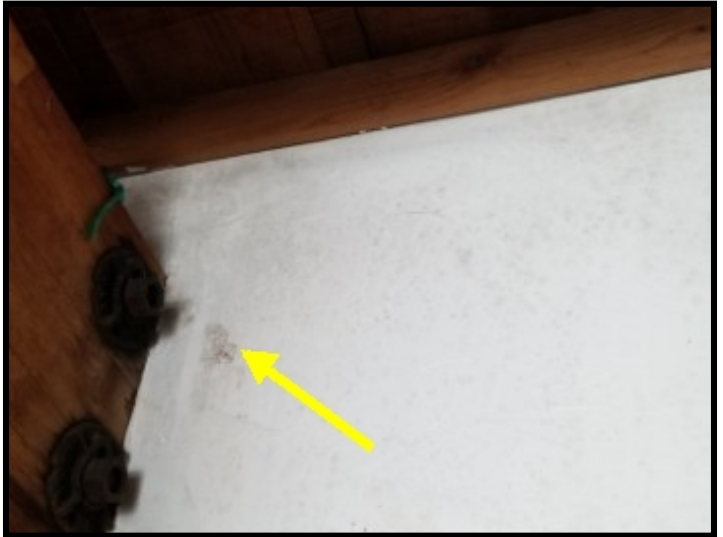
- 4.1. Damaged drywall above patio doors. Recommend removing drywall for further evaluation of wood framing
- 4.2. Organic growth on drywall on north wall. Recommend further testing and evaluation by mold specialist
- 4.3. Efflorescence on interior side of CMU walls. Efflorescence is a mineral deposit left behind from water penetrating walls

Organic growth

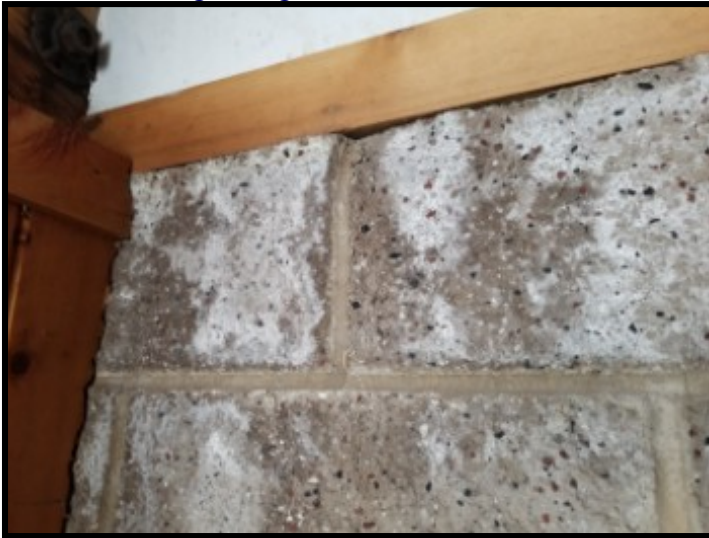
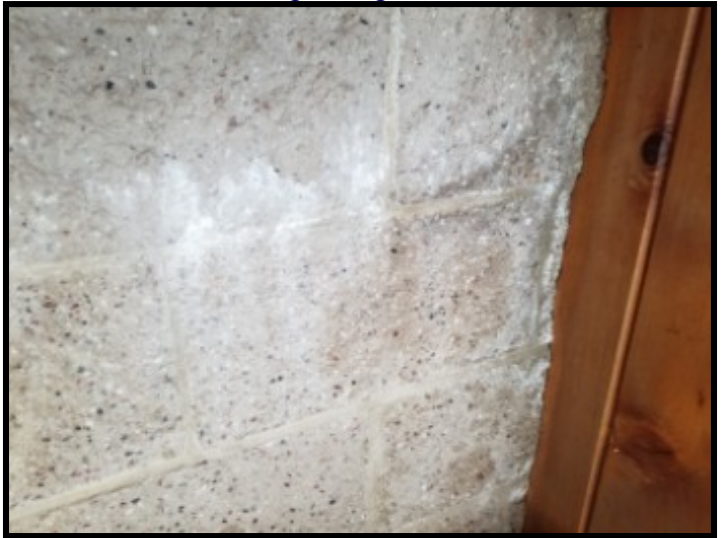
Efflorescence on CMU walls

Efflorescence

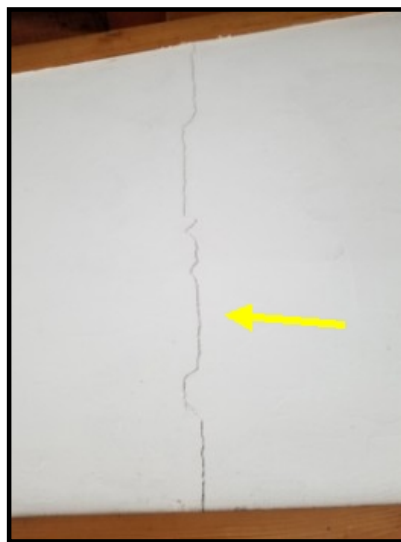
Cosmetic crack

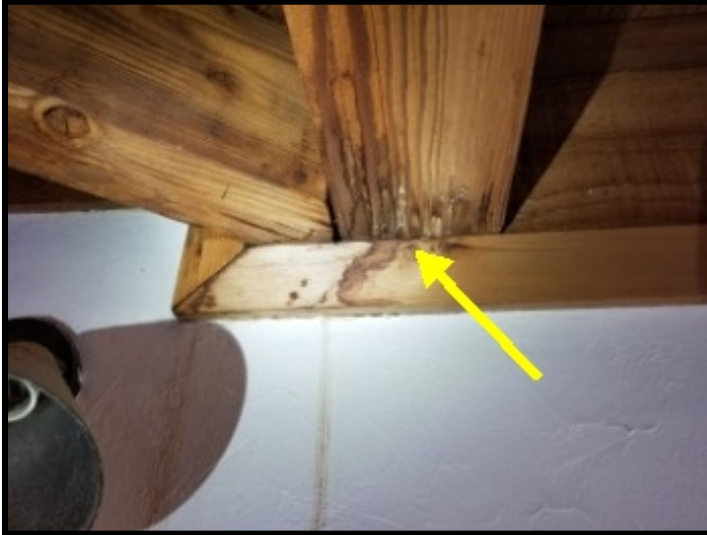
5.1. Extensive water staining on wood beam and decking. Some of these areas are moist. Roof appeared in poor condition in some areas. Recommend roof repair or replacement

Water stains above spa area

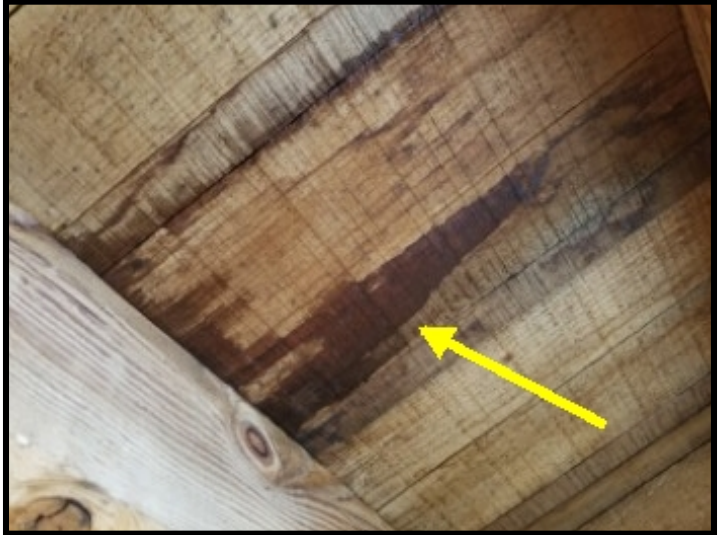
Moist decking above spa area

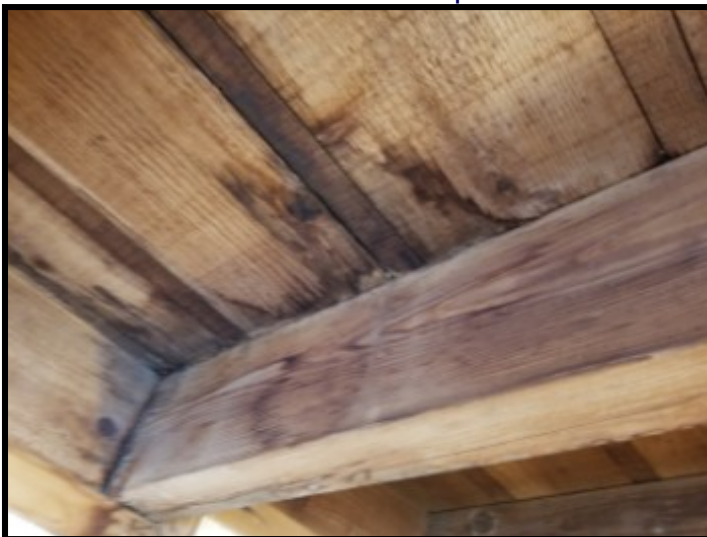
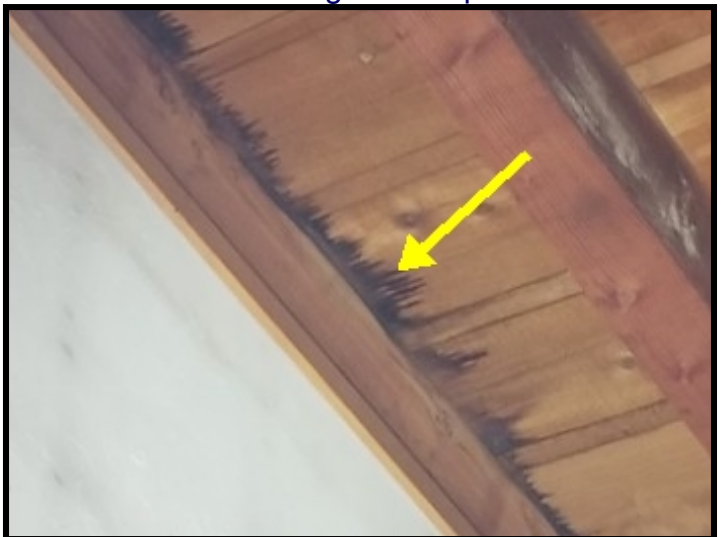
Water stains above pool area

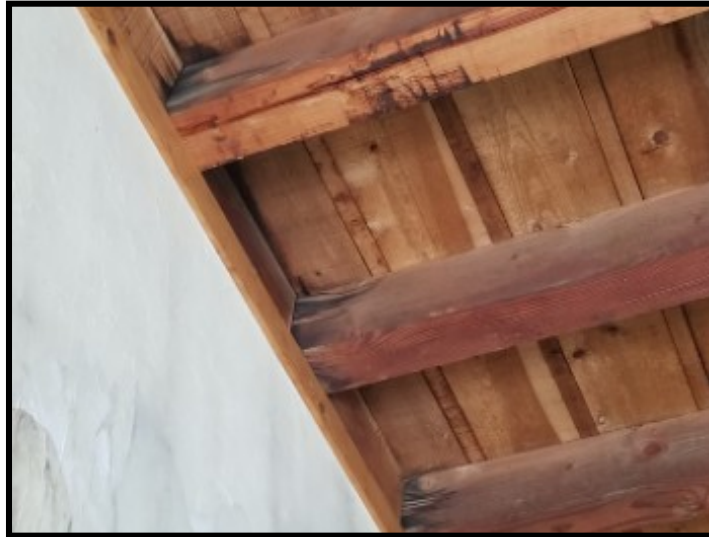
Water stains adjacent to gable end wall

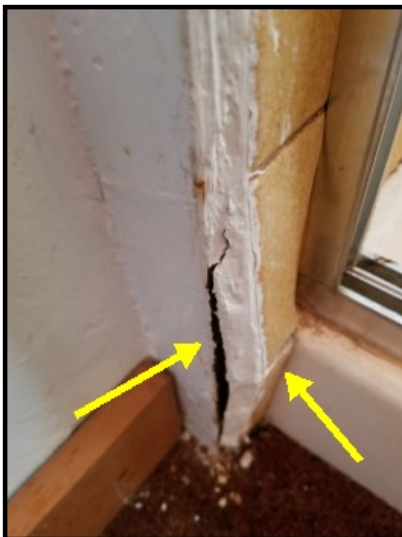
6.1. Cracks and missing grout around shower base and tile. Recommend resealing before use.

Cracked tile outside of shower

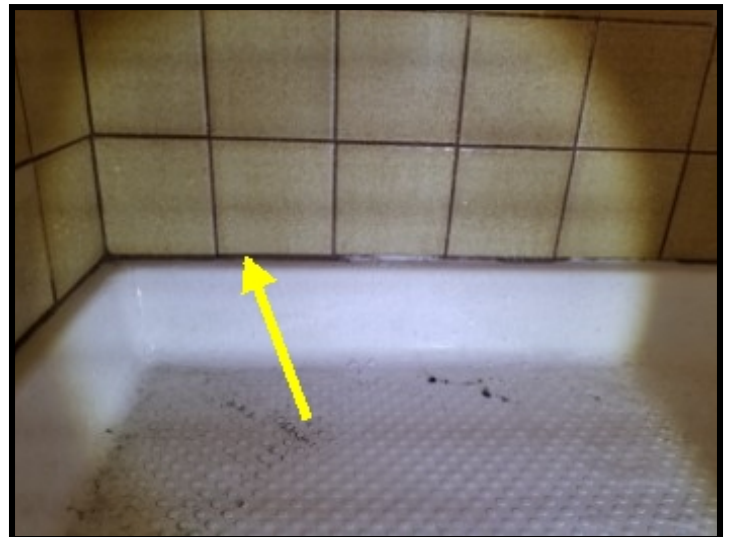
Cracked grout around shower base

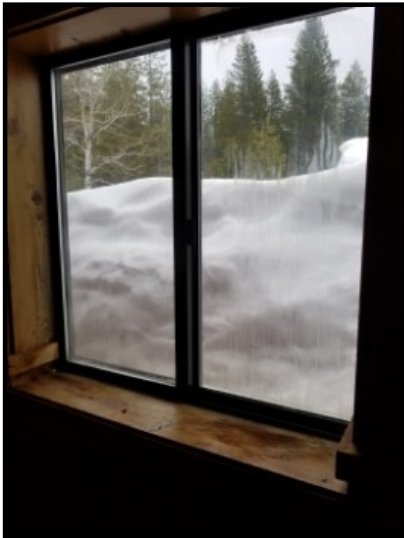
9.1. Cloudiness/condensation observed in all double pane windows in bathroom. This is an indication of a failed seal. A qualified contractor should review for replacement as needed.

Failed window seals

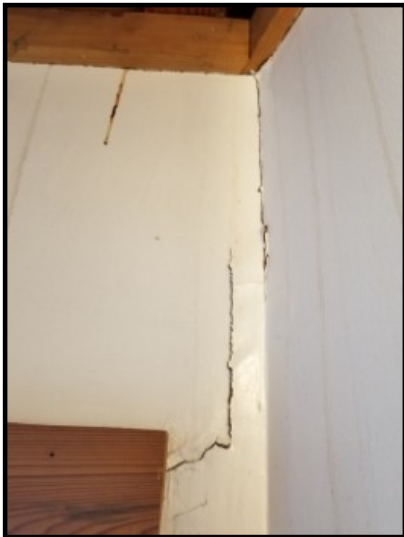
10.1. Cosmetic cracking observed and some water staining.

Cracked drywall and surface stains

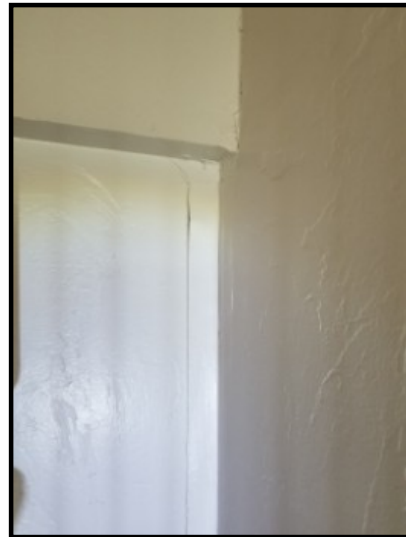
Drywall cracks

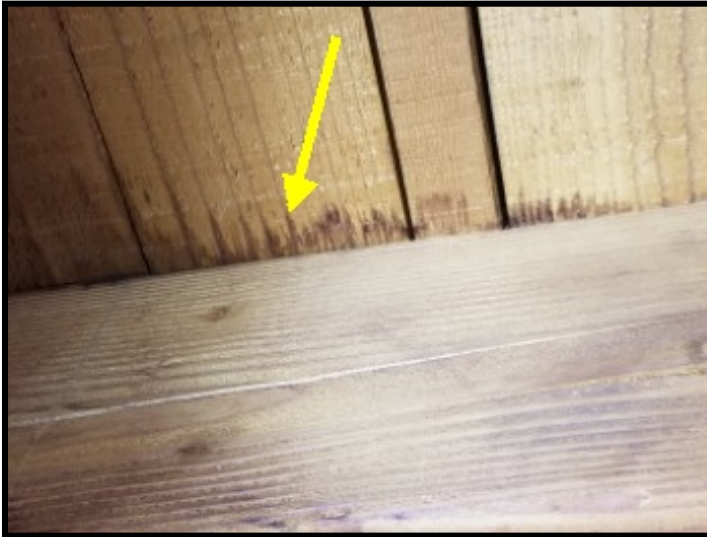
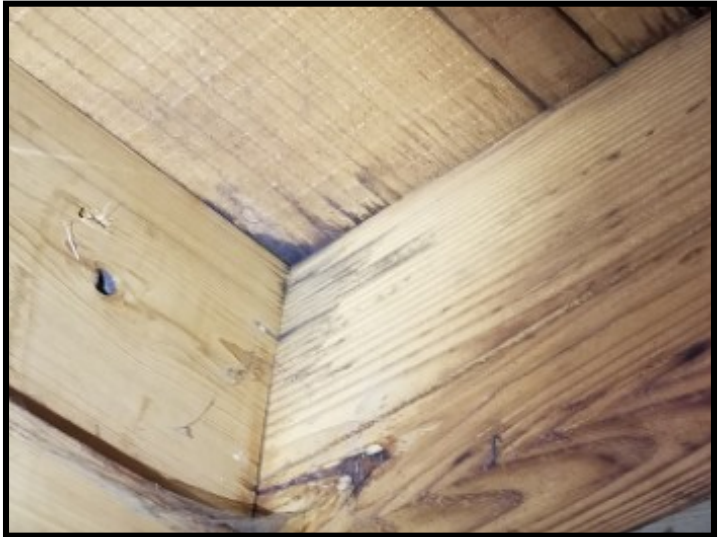
11.1. Water stains on wood decking above bathroom. Some stains showed elevated moisture content at time of inspection

Water stain

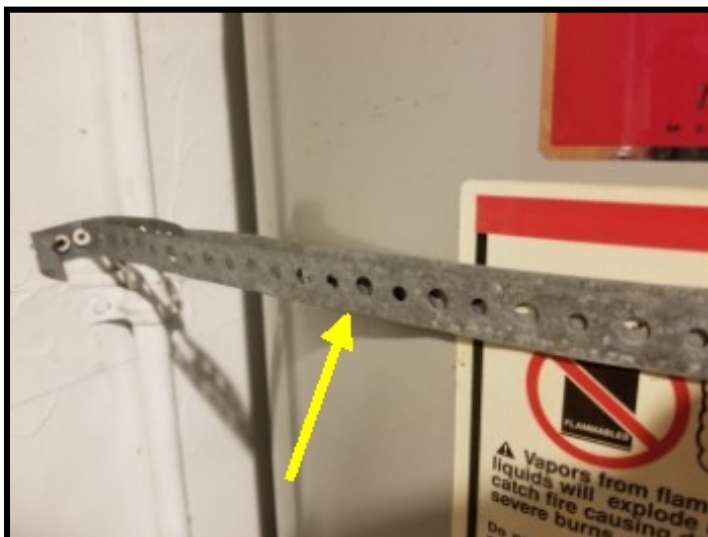
1.4. Plumber's tape used to strap water heater. This is not an acceptable method for strapping. Steel straps with lag screws or another approved method required

Plumber's tape is not an approved material for strapping

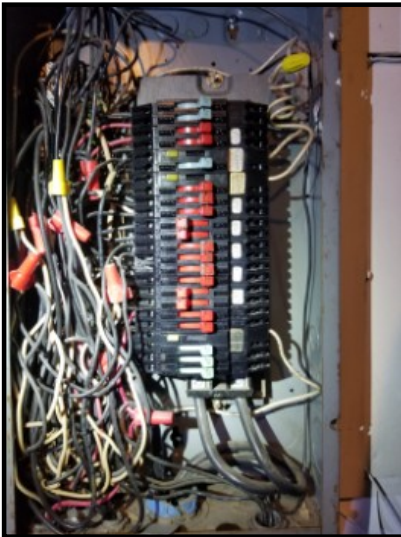
2.3. This sub panel is a Zinsco electrical panel. Zinsco electrical equipment is considered obsolete, due to a design flaw in which the circuit breaker's connection becomes loose, causing arcing and subsequent overheating. Long term exposure to this heat can cause the breaker's contacts to fuse together, thus preventing the breaker from tripping even in an overcurrent situation, thereby causing a potential fire hazard. Recommend replacing electrical panel by a licensed electrician.

Sub panel in mechanical room
