Property Inspection Report

325 Squaw Valley Rd, Olympic Valley, CA 96146

Date of Inspection: 4/4/2019 Time: 9:00 AM

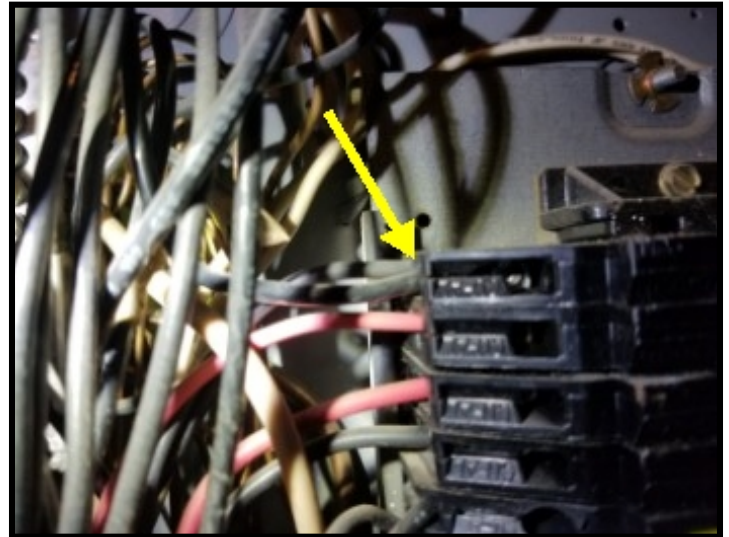
2.2. Double tapped breakers inside sub panel box (two electrical conductors attached to one breaker). This can cause overheating, arcing, and an electrical fire. Recommend repair by a licensed electrical contractor

Several double tapped breakers

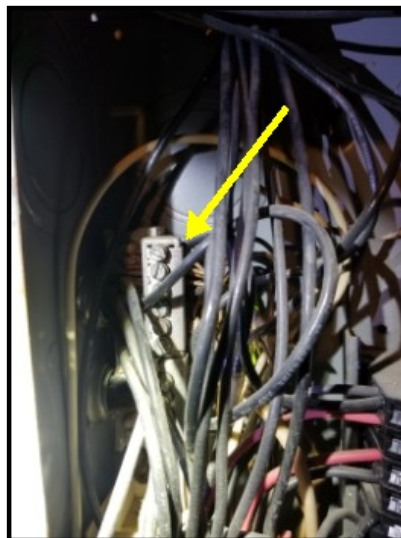
Ground and neutral wires connected to same bonding bar in sub panel

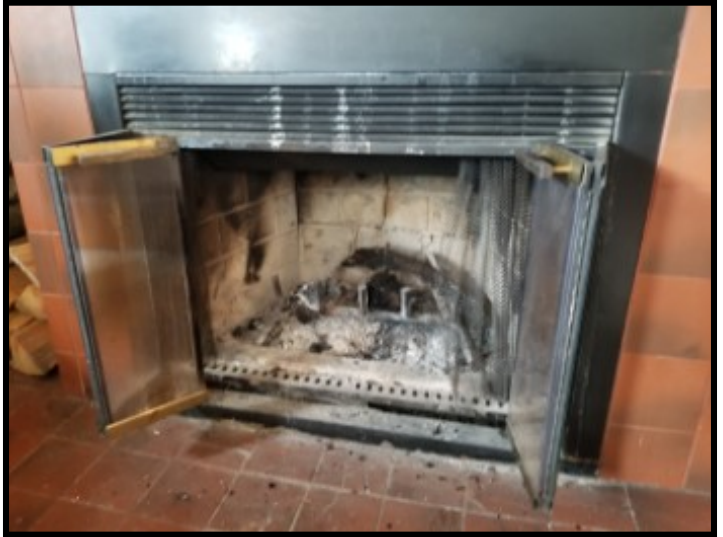
Wood burning fireplace in living room

9.1. Recommend sweeping chimney before use and annually to ensure safe operation.

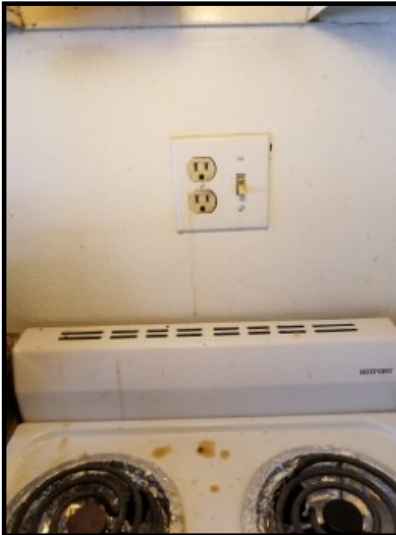
2.1. No GFCI protection present. Suggest installing GFCI protected receptacles for safety.

Kitchen outlets not GFCI protected

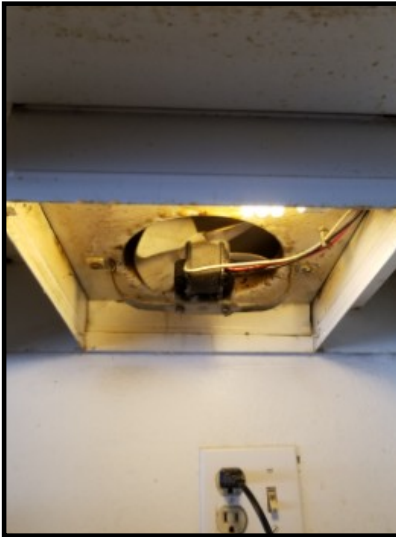
9.3. Recommend replacing fan filter, none present

Missing filter in exhaust fan

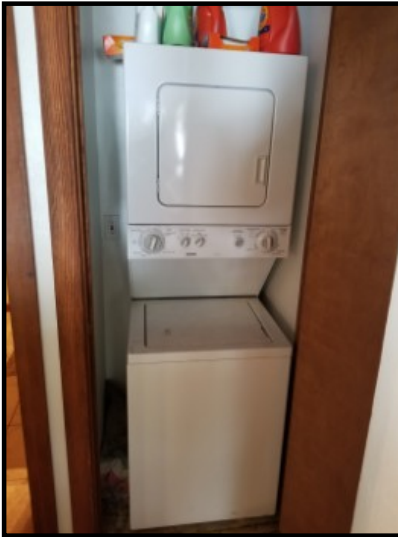
4.1. Could not fully inspect the dryer vent; it is obscured by adjacent walls

Washer and dryer in closet

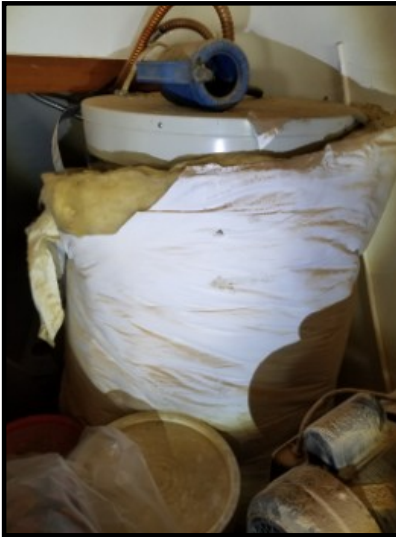
1.1. No expansion tank installed at water heater. An expansion tank prevents damage to valves, pipes, and the water heater by allowing a place for water to go when it expands from being heated. Contact a licensed plumbing contractor for installation

1.2. Unable to thoroughly inspect water heater or determine date of manufacture due to insulation wrap and personal items blocking unit.

1.3. The water heater has one strap visible. Verify if unit is properly secured with second strap.

Garage residence water heater

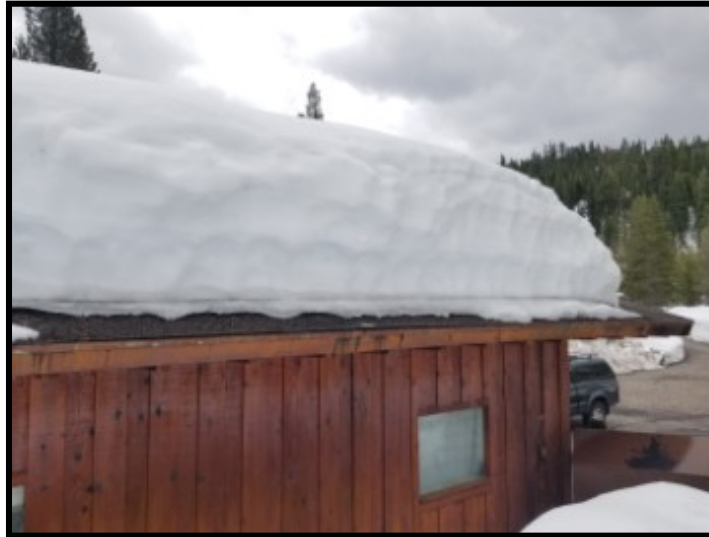
1.1. Roof was mostly snow covered at the time of inspection. These areas of the roof were unable to be inspected

1.2. Visible areas appeared in marginal to poor condition. Recommend having roof evaluated by licensed roofing contractor when snow melts

Snow on roof

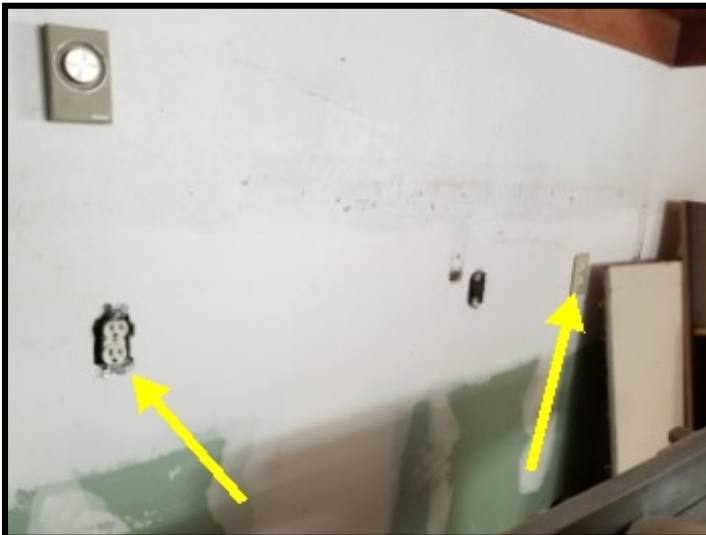
Some outlets in shop are not GFCI protected

2.1. Some outlets are not GFCI protected. Contact licensed electrical contractor for repair

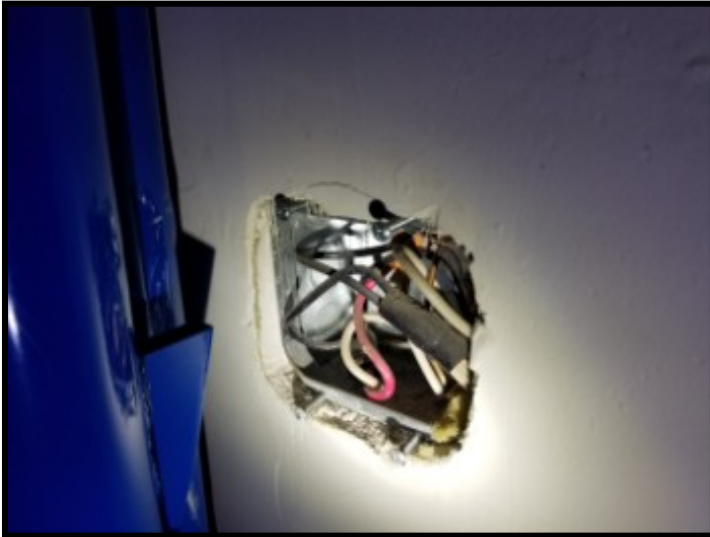
1.2. Open junction box observed in garage. Install cover for safety

Open junction box

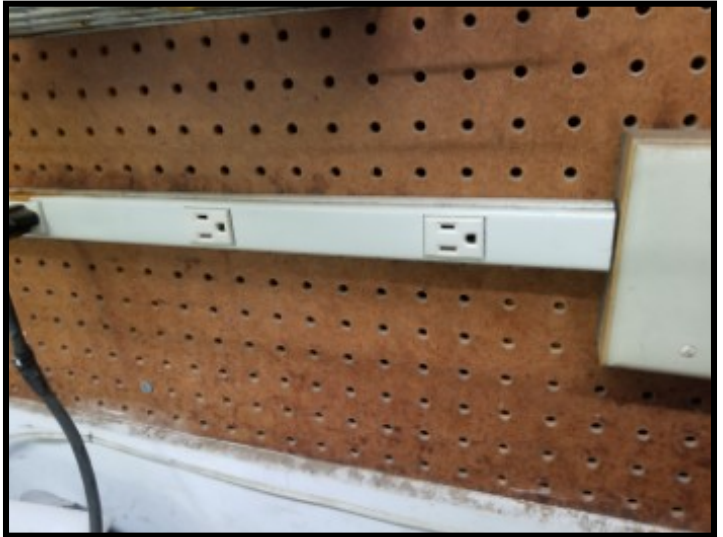
Outlets in garage not GFCI protected

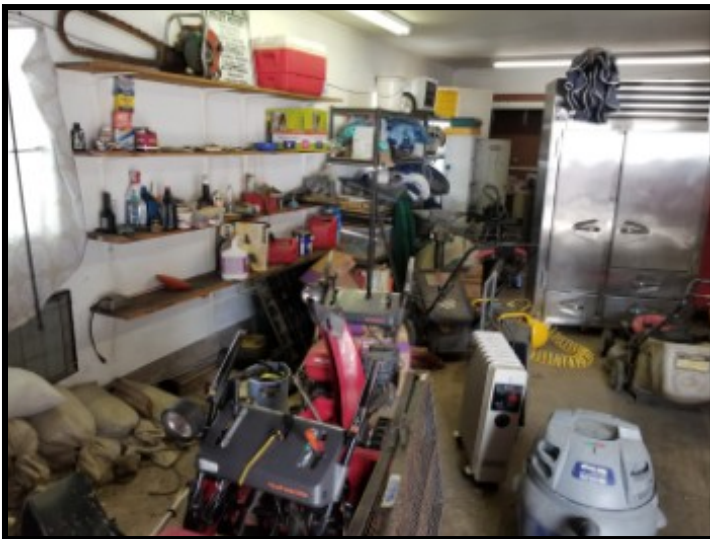
3.1. Personal items prevent complete inspection.

Personal items in garage

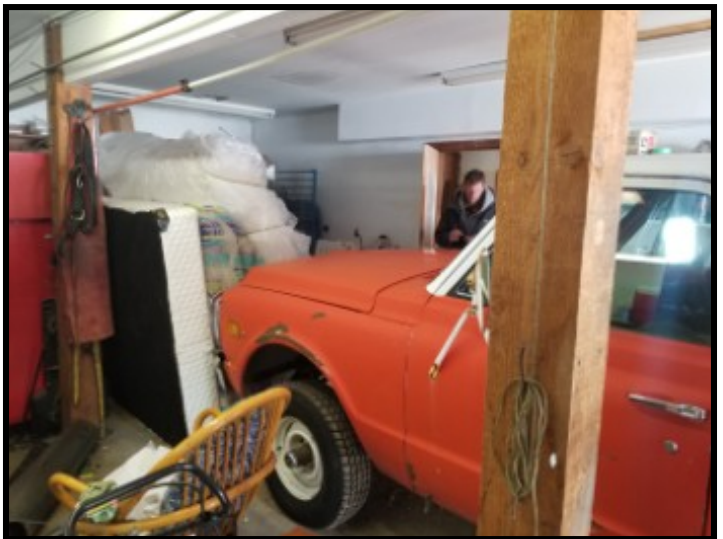
Car and personal items in garage

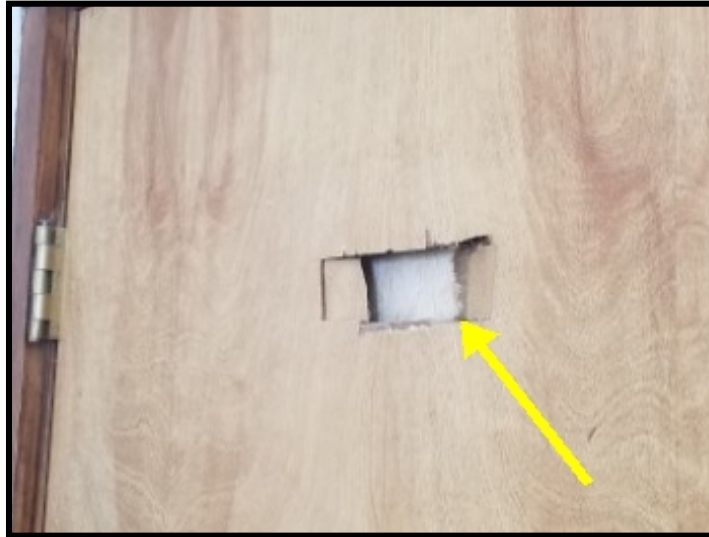
7.1. Door to shop has hole in it

Door to shop has hole in it

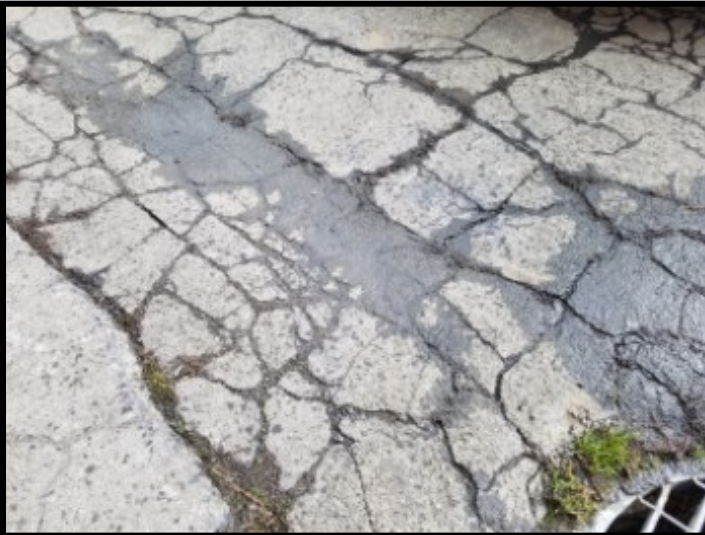
1.1. Moderate cracks and deterioration in driveway. Repair and/or monitor for development trip hazards or further deterioration. Recommend sealing to extend life.

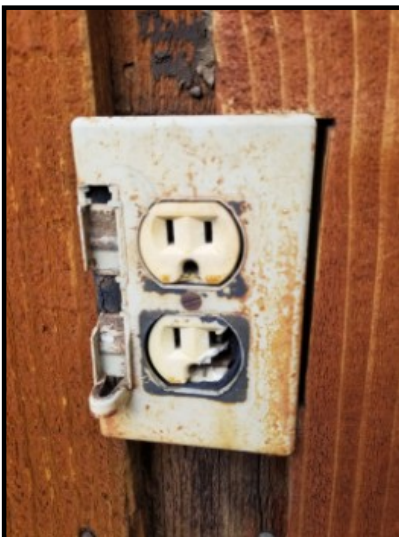
5.1. Outlet at front of garage is damaged, missing a weatherproof cover and is not GFCI protected. Contact licensed electrical contractor for repair

Damaged outlet is not GFCI protected

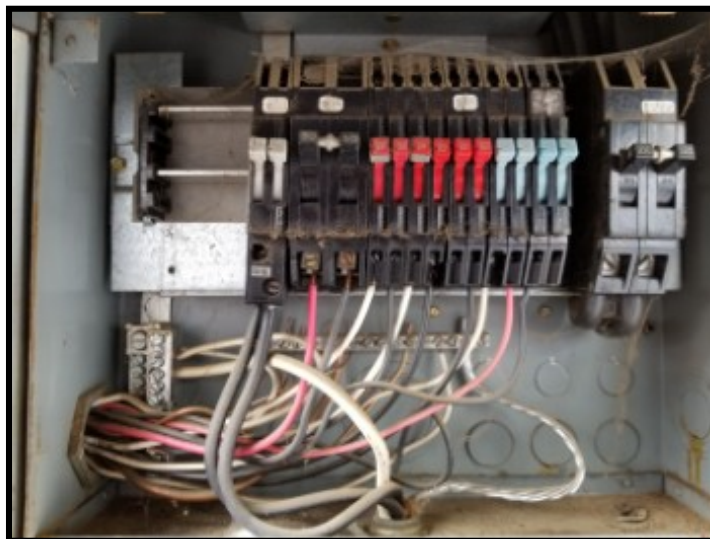
Main panel for residence

2.2. Both main panels are Zinsco electrical panels. Zinsco electrical equipment is considered obsolete, due to a design flaw in which the circuit breaker's connection becomes loose, causing arcing and subsequent overheating. Long term exposure to this heat can cause the breaker's contacts to fuse together, thus preventing the breaker from tripping even in an overcurrent situation, thereby causing a potential fire hazard. Recommend replacing electrical panel by a licensed electrician.

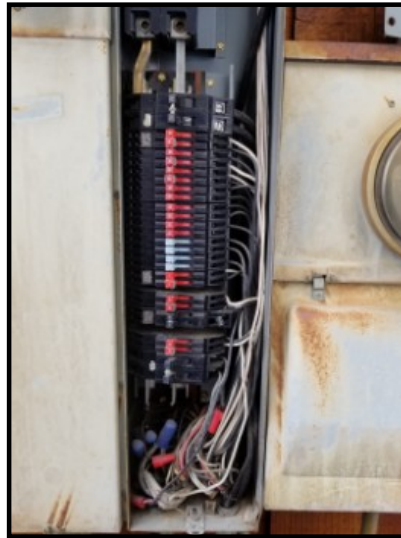
Main panel for garage
